# **OKEHOCKING PRESERVE TRAIL SYSTEM**

## **TRAIL ASSESSMENT AND PRESCRIPTIONS REPORT**

**JUNE 2, 2016**

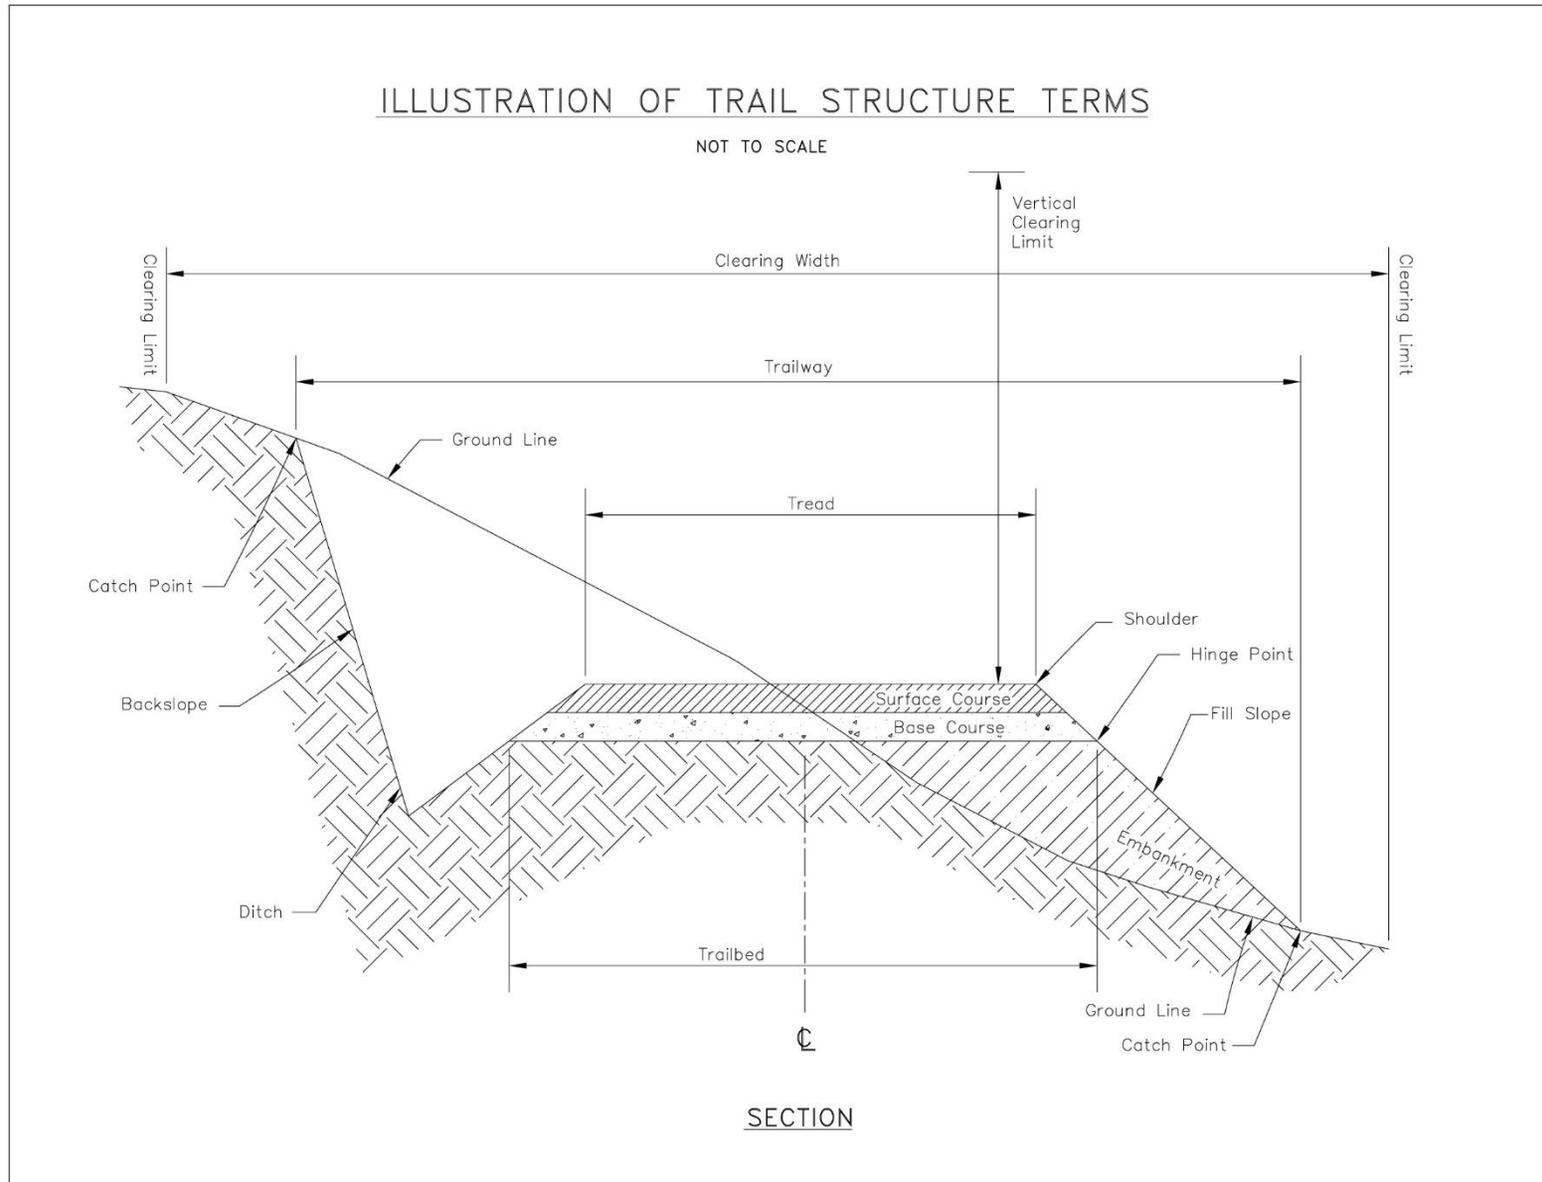
## B. Trail Structural Terminology

The Penn Trails assessment process observes and records the physical conditions of the trail’s structural components (see Trail Structural Terminology diagram below). These observations are then related to Productivity Factors, which determine the trail’s structural stability and sustainability. The assessed productivity factors for the Okehocking Preserve Trail system are:

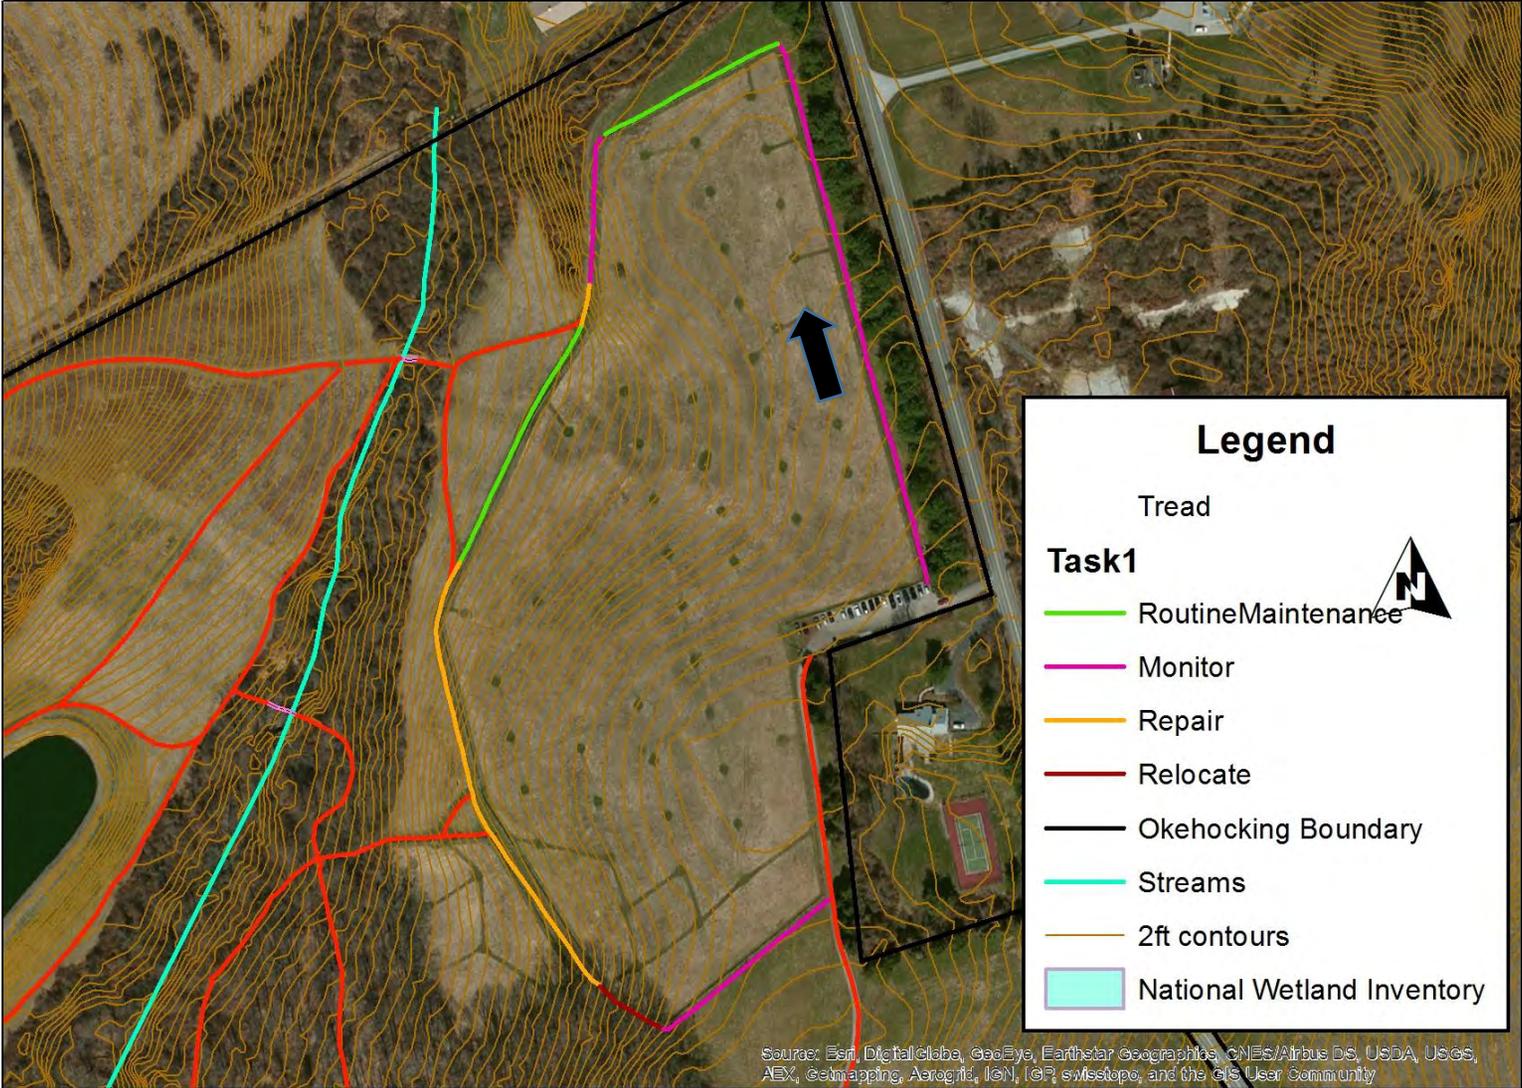
Trail 1 Tread Task 1

Trail 1												
FID	SurfaceMaterial	Vegetation	TreadWidth	TrailGrade	CrossSlope	SideSlope	TreadTask1	TreadTask2	ClearingHeight	ClearingWidth	ClearingTask	Length
0	Grass	Grass	<12	<5	>1	<5	Monitor	None	97-144	80+	RoutineMaintenance	763
1	Grass	Grass	<12	5-10	<5	<5	RoutineMaintenance	None	97-144	80+	RoutineMaintenance	266
2	Grass	Grass	<12	5-10	0	5-10	Monitor	None	97-144	80+	RoutineMaintenance	64
3	Grass	Grass	<12	16-20	0	<5	Monitor	None	97-144	80+	RoutineMaintenance	137
4	Grass	Grass	<12	>20	0	<5	Repair	CrownAndCompact	97-144	80+	RoutineMaintenance	58
5	Grass	Grass	<12	5-10	<5	<5	RoutineMaintenance	None	97-144	80+	RoutineMaintenance	358
6	Grass	Grass	<12	5-10	>5	5-10	Repair	FullBenchConstruction	97-144	80+	RoutineMaintenance	88
7	Dirt	Grass	<12	11-15	>1	11-15	Repair	OutslopeTread/add dips	97-144	80+	RoutineMaintenance	177
8	Dirt	Grass	<12	<5	>1	<5	Repair	OutslopeTread/add dips	97-144	80+	RoutineMaintenance	329

9	Dirt	Grass	13-25	16-20	0	16-20	Repair	CrownAndCompact	97-144	80+	RoutineMaintenance	47
10	Dirt	Grass	>60	>20	0	16-20	Relocate	None	97-144	80+	RoutineMaintenance	106
11	Grass	Grass	<12	5-10	<5	5-10	Monitor	None	97-144	80+	RoutineMaintenance	288
											Total (ft)	2681

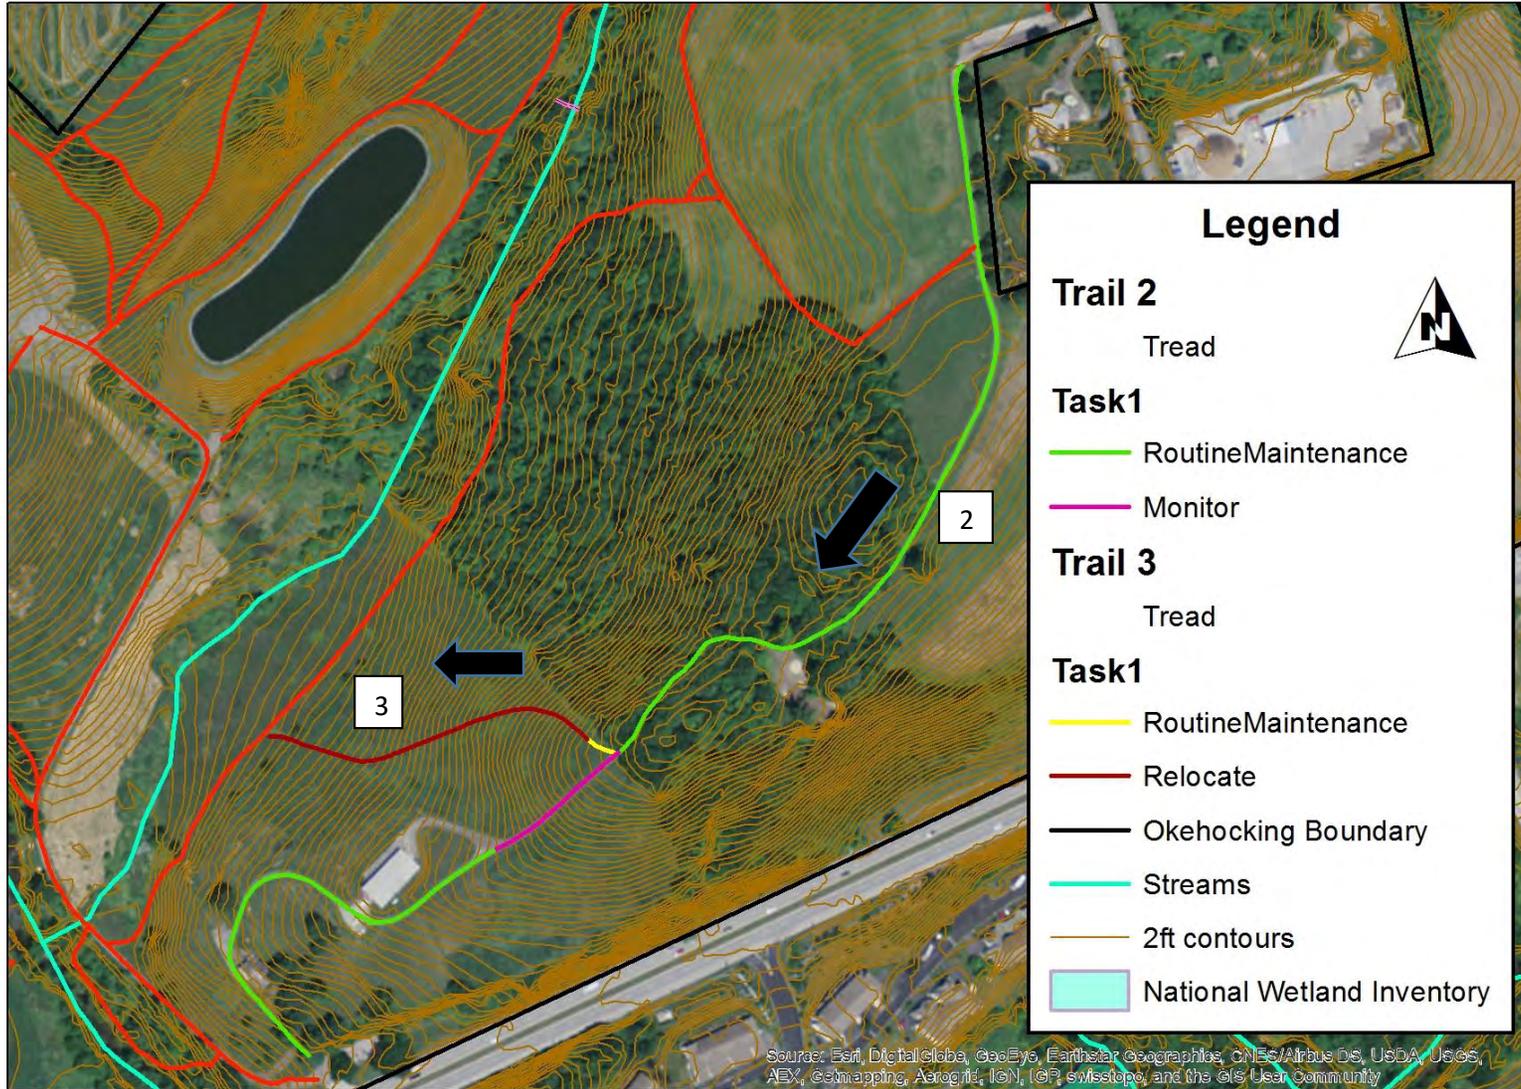
### Trail 2 & 3 Tread Task 1

Trail 2 begins at the Delchester Rd. parking lot at the gate and Information Kiosk. The trail is an access road for employees to travel internally through the Preserve with equipment for maintenance duties. Trail 2 ends at the Westchester Pike parking lot. The trail tread is loose aggregate that is well maintained by staff. Sections of the trail that exceed the short pitch max show some erosion and compaction.

Trail 3 offers a connection between Trailhead 1 (Delchester Rd) and Trailhead 2 (Westchester Pike) with a turf surface. The trail is fall line and steep with a fair amount of use from all user groups. Signs of trail widening and cupping are seen within these sections. Although erosion is present this trail offers the user a more stable surface then the loose aggregate of Trail 2.

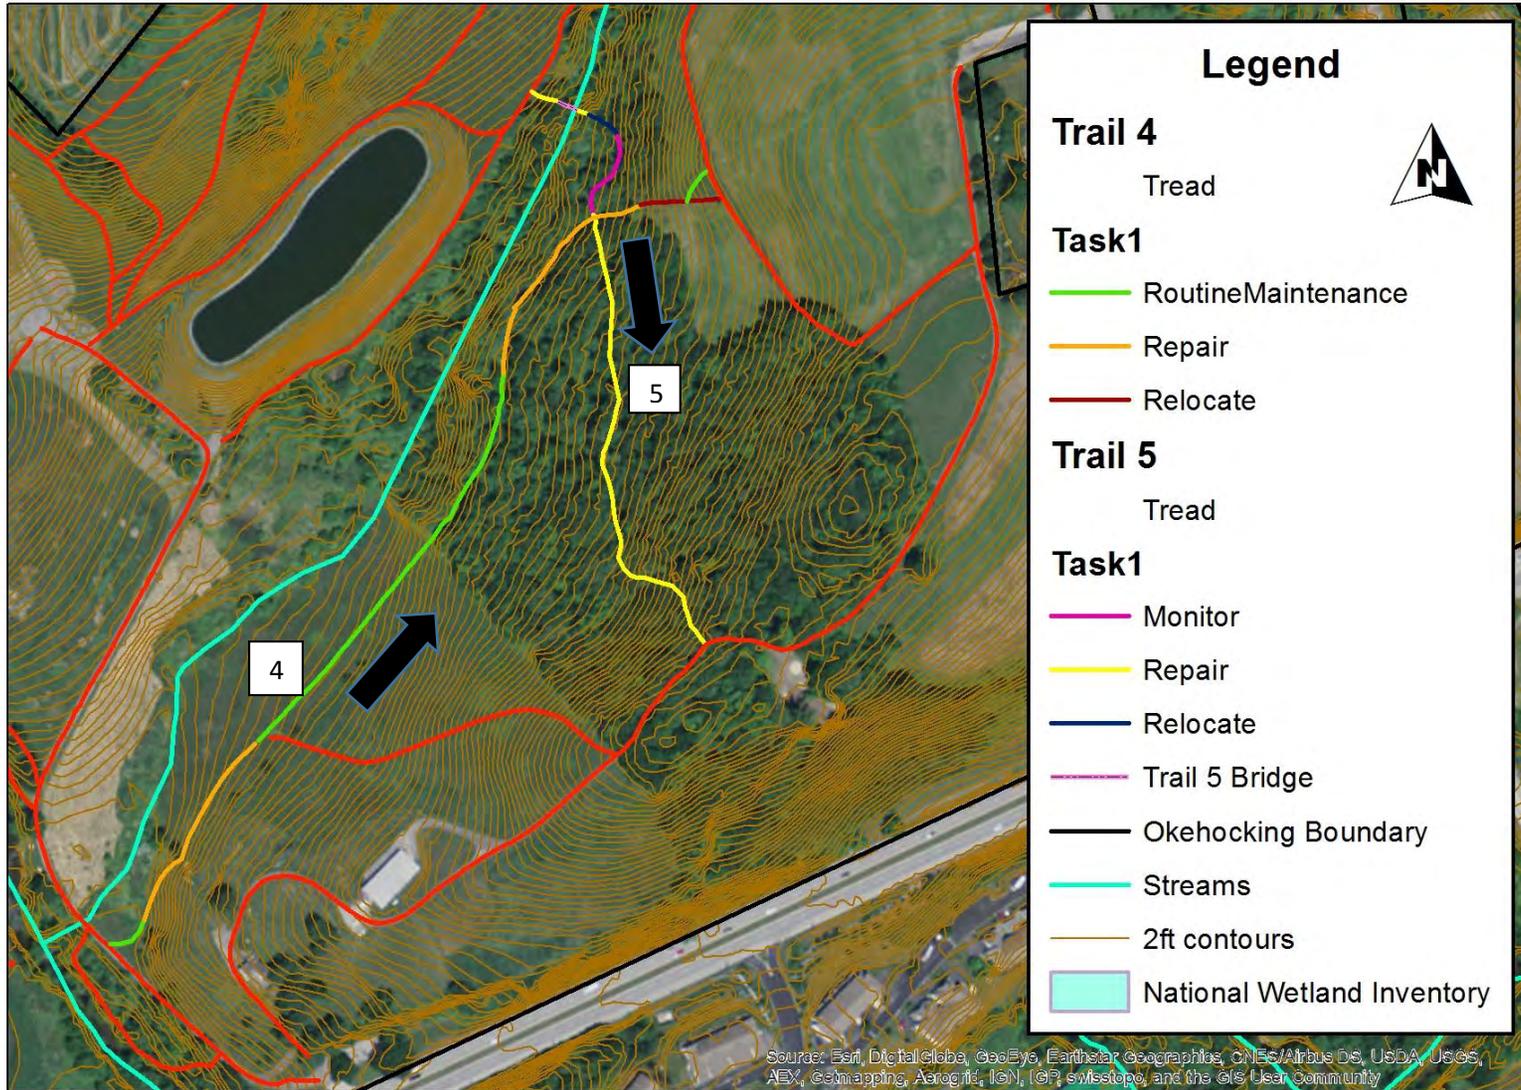
### Trail 4 & 5 Tread Task 1

Trail 4 traverses through the meadow and woodlands, it is the south/east section of a larger loop advertised in the Okehocking Preserve Brochure. The trail is highly used with almost two apparent treads through the meadow area. The beginning of the trail (starting at trail 2) is choked by a small stream to the west and an old retaining wall to the east. This choking point has limited sight lines and may instigate user conflict. My recommendation would be to open the corridor on the east side to allow for better sight lines.

Trail 4												
FID	SurfaceMaterial	Vegetation	TreadWidth	TrailGrade	CrossSlope	SideSlope	TreadTask1	TreadTask2	ClearingHeight	ClearingWidth	ClearingTask	Length
0	Grass	Grass	13-25	<5	0	<5	RoutineMaintenance	None	Open	80+	RoutineMaintenance	85
1	Grass	Grass	<12	<5	>-1	5-10	Repair	OutslopeTread/add dips	Open	80+	RoutineMaintenance	134
2	Dirt	Grass	<12	<5	>5	11-15	Repair	FullBenchConstruction	Open	80+	RoutineMaintenance	252
3	Grass	Grass	<12	<5	<5	5-10	RoutineMaintenance	None	Open	80+	RoutineMaintenance	474
4	Dirt	MatureForest	13-25	5-10	0	5-10	RoutineMaintenance	None	73-96	61-80	RoutineMaintenance	344
5	Dirt	MatureForest	13-25	5-10	>-1	5-10	Repair	CrownAndCompact	73-96	61-80	RoutineMaintenance	119
6	Dirt	MatureForest	13-25	<5	>-1	5-10	Repair	OutslopeTread/add dips	73-96	61-80	RoutineMaintenance	164
7	Dirt	MatureForest	41-60	11-15	>5	11-15	Repair	CrownAndCompact or relocate	73-96	61-80	RoutineMaintenance	149

Old deer fencing near the intersection of Trail 5 and 2 needs repair or removal.

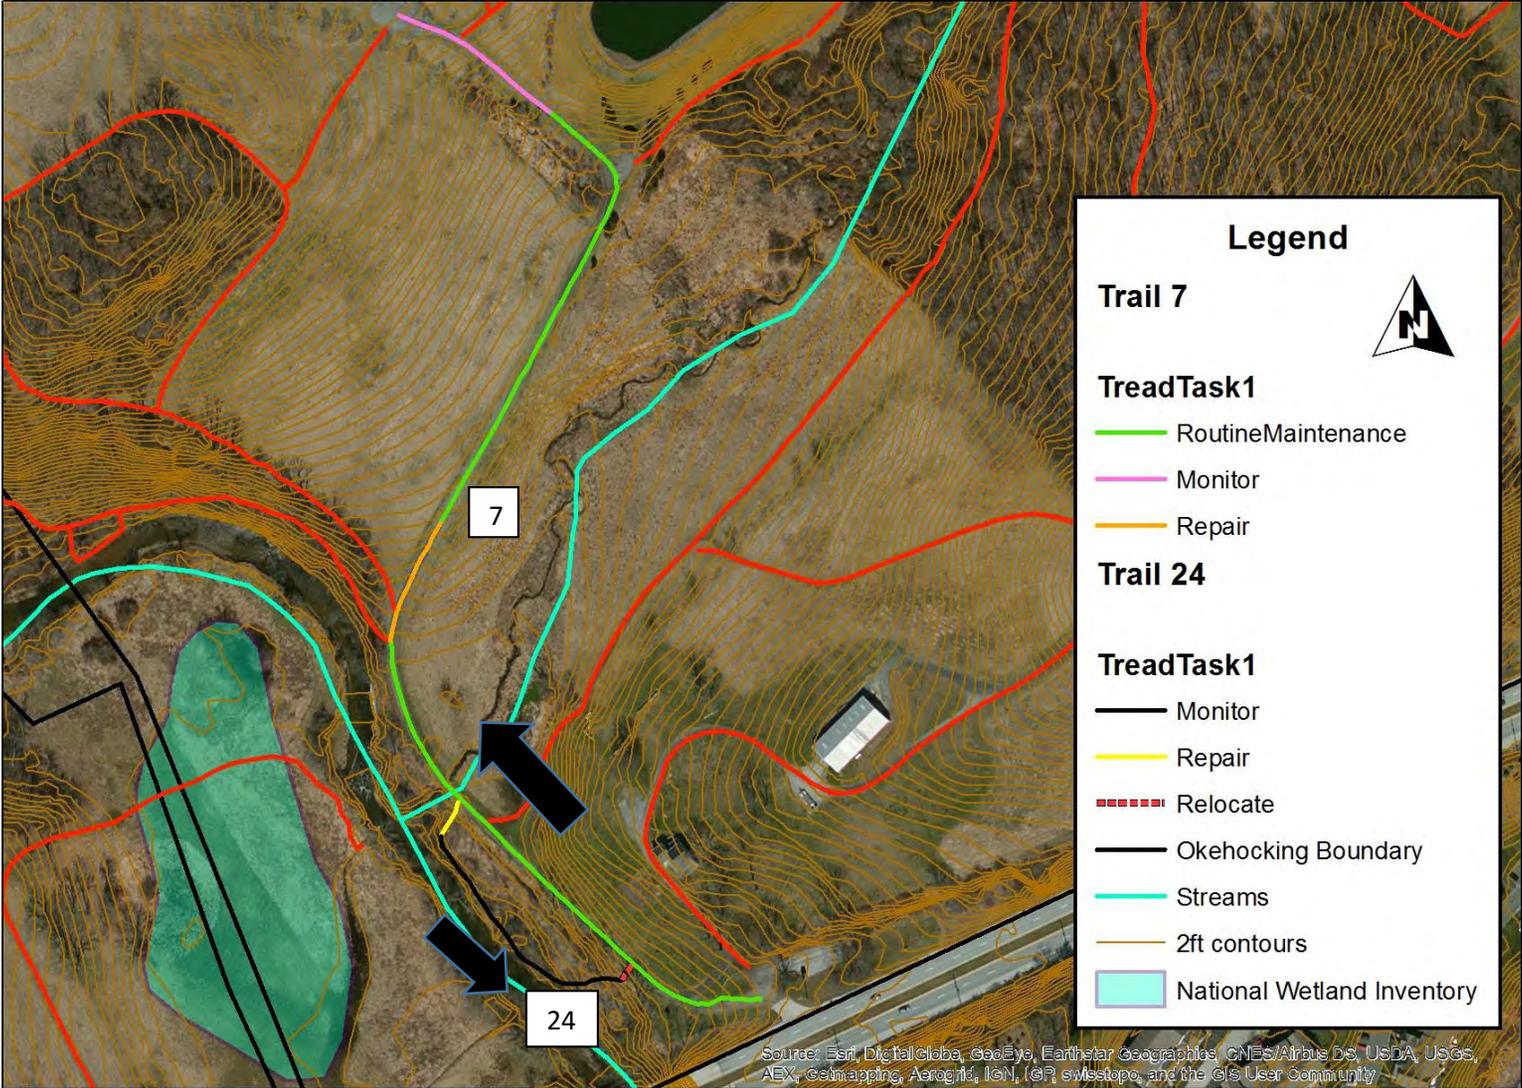
Trail 7 & 24 Tread Task 1

Trail 7 is an access road for general maintenance of the Preserve; including the Pump House and Ponds. It has a loose aggregate tread that is maintained. One section North/West of the Pump House is showing erosion due to its steep grade. Users can access many trail and amenities from Trail 7.

Trail 7													
FID	SurfaceType	SurfaceMaterial	Vegetation	TreadWidth	TrailGrade	CrossSlope	SideSlope	TreadTask	TreadTask2	ClearingHeight	ClearingWidth	ClearingTask	Length
0	Aggregate	gravel	Grass	80+	11-15	0	<5	RoutineMaintenance	None	Open	80+	RoutineMaintenance	87
1	Aggregate	gravel	Grass	80+	<5	<5	<5	RoutineMaintenance	None	Open	80+	RoutineMaintenance	692
2	Aggregate	gravel	Grass	80+	11-15	>-1	11-15	Repair	CrownAndCompact	Open	80+	RoutineMaintenance	184
3	Aggregate	gravel	Grass	80+	5-10	0	5-10	RoutineMaintenance	None	Open	80+	RoutineMaintenance	120
4	Aggregate	gravel	Grass	80+	<5	0	5-10	RoutineMaintenance	None	Open	80+	RoutineMaintenance	460
5	Aggregate	gravel	Grass	80+	5-10	0	5-10	RoutineMaintenance	None	Open	80+	RoutineMaintenance	95
6	Aggregate	gravel	Grass	80+	11-15	0	11-15	Monitor	None	Open	80+	RoutineMaintenance	252
												Total (ft)	1890

<b>Trail 24</b>												
FID	SurfaceMaterial	Vegetation	TreadWidth	TrailGrade	CrossSlope	SideSlope	TreadTask1	TreadTask2	ClearingHeight	ClearingWidth	ClearingTask	Length
0	Dirt	YoungForest	13-25	5-10	0	5-10	Repair	CrownAndCompact	61-72	25-40	RoutineMaintenance	53
1	Dirt	YoungForest	13-25	<5	0	5-10	Monitor	None	61-72	25-40	RoutineMaintenance	46
2	Dirt	YoungForest	<12	<5	0	5-10	Monitor	None	<60	25-40	RoutineMaintenance	230
3	Dirt	YoungForest	13-25	11-15	0	11-15	Monitor	None	73-96	61-80	RoutineMaintenance	83
4	Dirt	YoungForest	13-25	>20	0	>20	Relocate	None	73-96	61-80	RoutineMaintenance	29
											Total (ft)	441

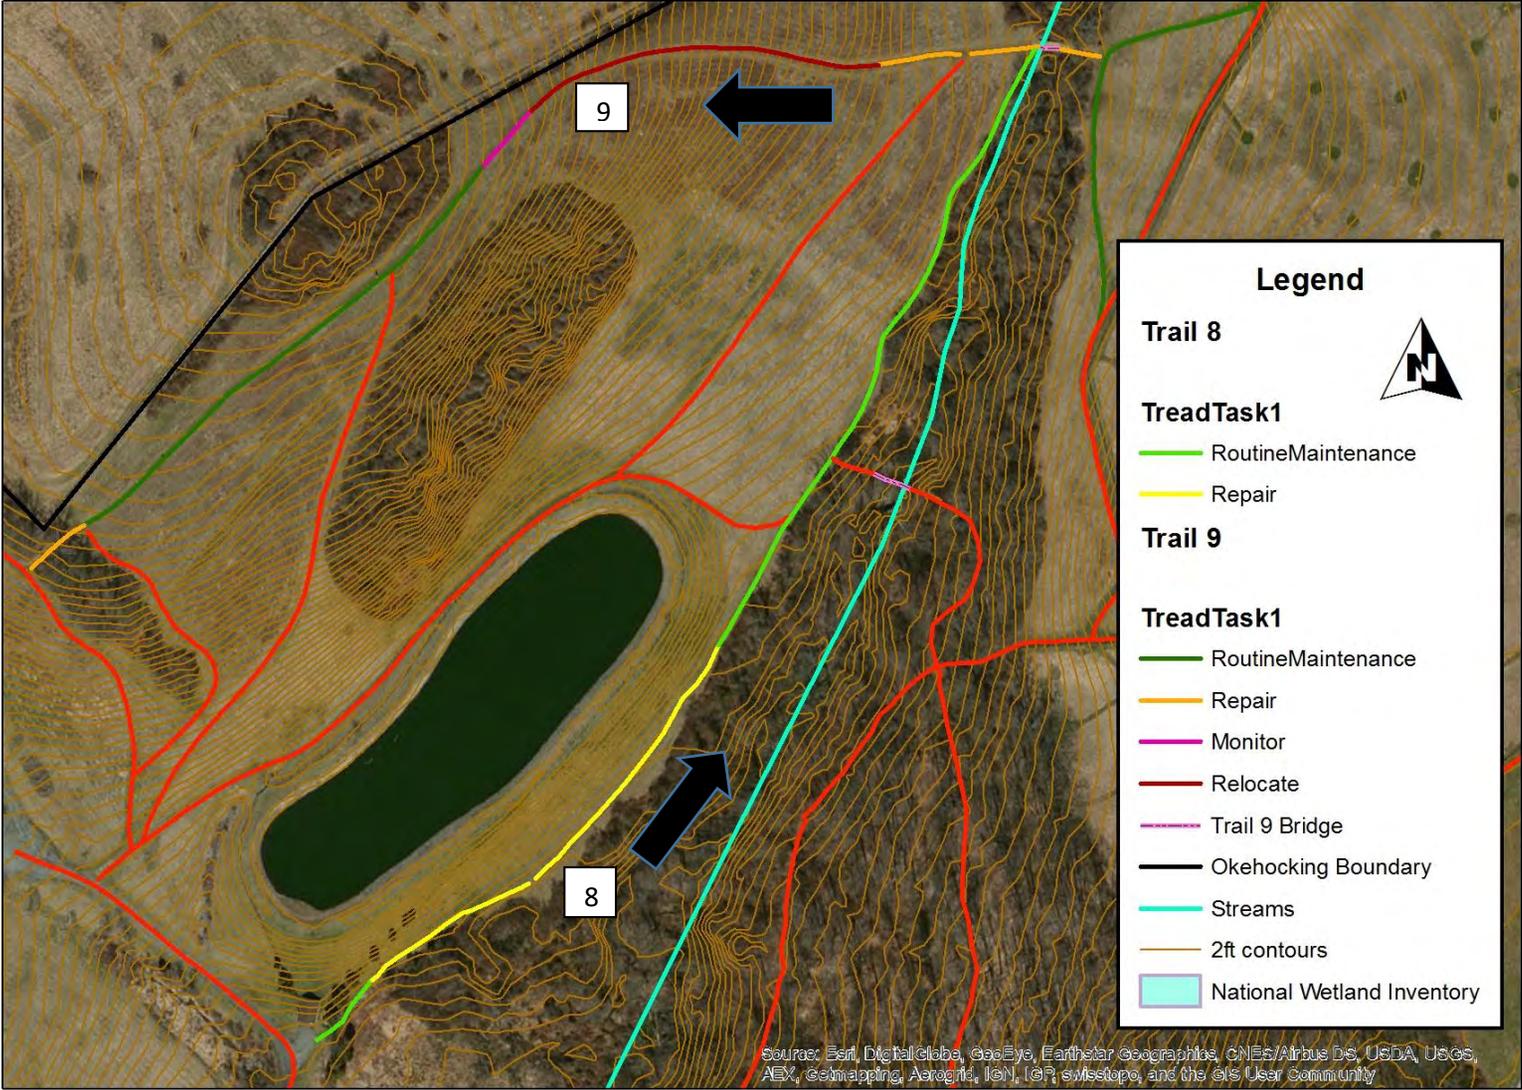
Trails 8 & 9 Tread Task 1

Trail 9												
FID	SurfaceMaterial	Vegetation	TreadWidth	TrailGrade	CrossSlope	SideSlope	TreadTask1	TreadTask2	ClearingHeight	ClearingWidth	ClearingTask	Length
0	Grass	Grass	80+	11-15	0	11-15	RoutineMaintenance	None	Open	80+	RoutineMaintenance	52
1	Grass	Grass	80+	5-10	0	5-10	RoutineMaintenance	None	Open	80+	RoutineMaintenance	94
2	Grass	Grass	80+	<5	0	5-10	RoutineMaintenance	None	Open	80+	RoutineMaintenance	145
3	Grass	Grass	80+	5-10	<5	5-10	RoutineMaintenance	None	Open	80+	RoutineMaintenance	187
4	Dirt	Shrub/Sapling	80+	11-15	>5	11-15	Repair	CrownAndCompact	Open	80+	RoutineMaintenance	43
5	Grass	Grass	80+	5-10	0	5-10	RoutineMaintenance	None	Open	80+	RoutineMaintenance	74
6	Grass	Grass	80+	11-15	>5	11-15	Repair	CrownAndCompact	Open	80+	RoutineMaintenance	90
7	Grass	Grass	80+	>20	0	>20	Relocate	None	Open	80+	RoutineMaintenance	156
8	Grass	Grass	80+	>30	0	>30	Relocate	None	Open	80+	RoutineMaintenance	251

9	Grass	Grass	80+	11-15	>-1	11-15	Monitor	None	Open	80+	RoutineMaintenance	79
10	Grass	Grass	80+	5-10	<5	5-10	RoutineMaintenance	None	Open	80+	RoutineMaintenance	148
11	Grass	Grass	80+	<5	<5	<5	RoutineMaintenance	None	Open	80+	RoutineMaintenance	445
12	Dirt	MatureForest	25-40	11-15	>-1	11-15	Repair	CrownAndCompact	61-72	61-80	Repair/Vertical Clearance	75
											Total (ft)	1839

Trail 9 Bridge												
FID	Type	Handrail	TreadGrade	TreadCrossSlope	Length(ft)	Width(in)	HtAboveGround(in)	FrameMaterial	TreadMaterial	Footers	FooterMaterial	FeatureTask
0	Single Unit	No	<5	0	23	100	48	Metal	Treated Lumber	Yes	Concrete	RoutineMaintenance

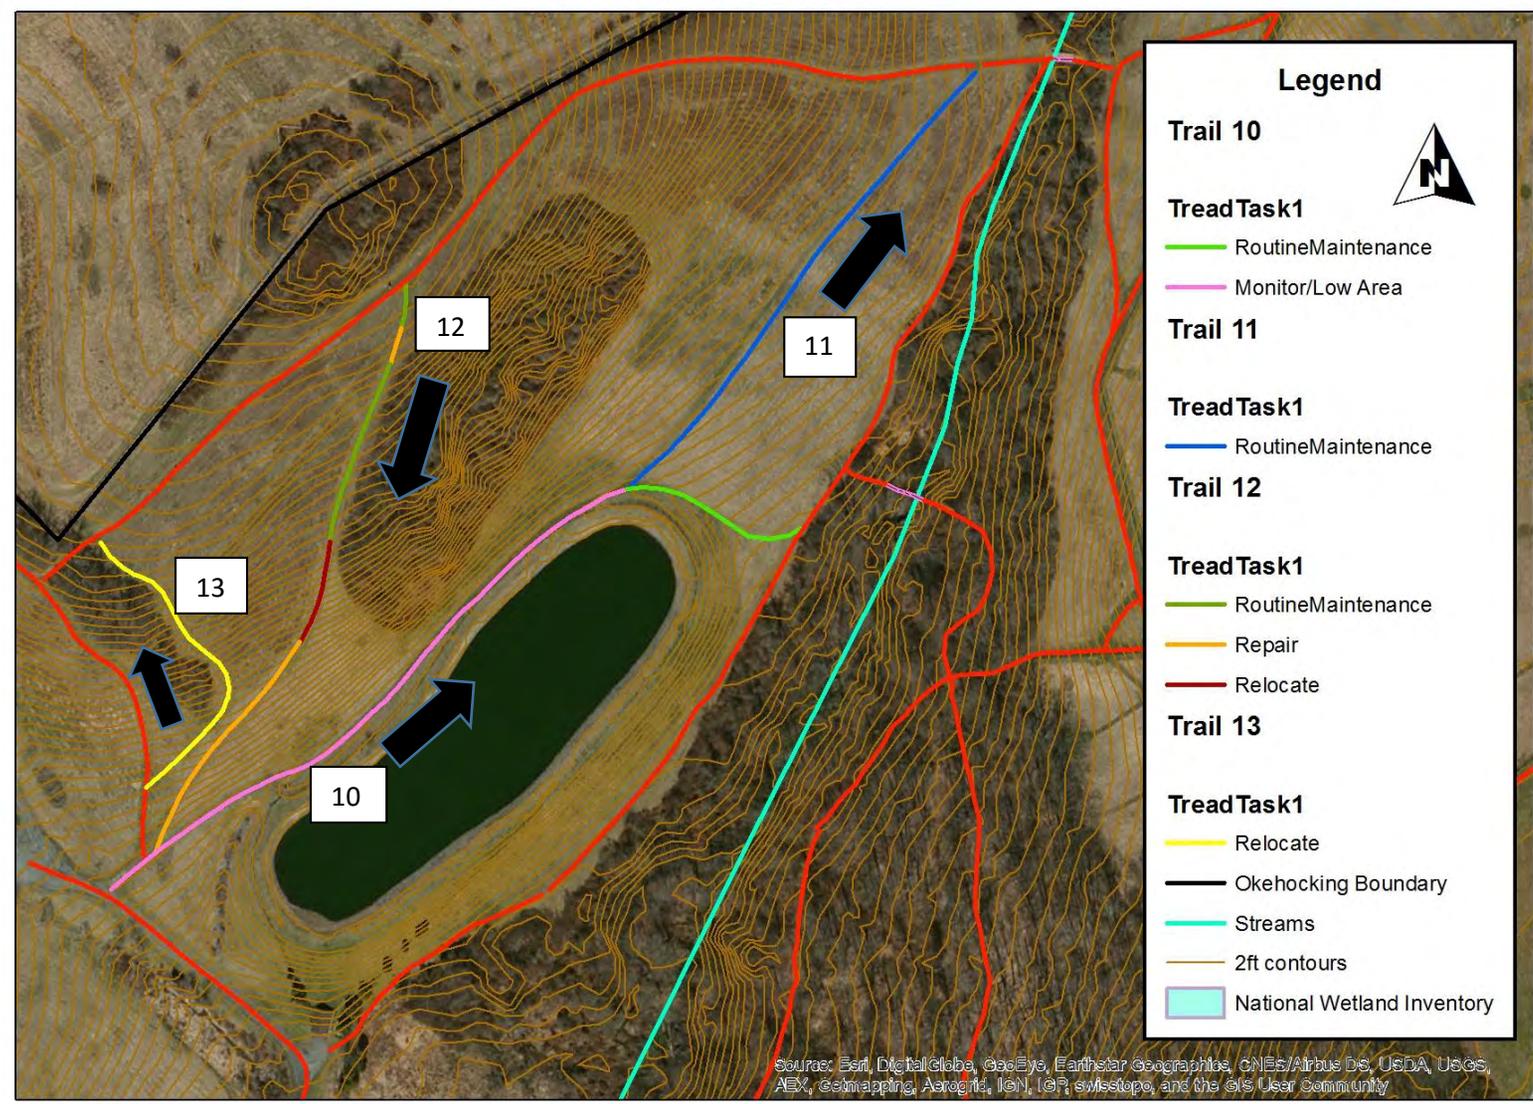
### Trails 10-13 Tread Task 1

Trail 10 is utilized by bird watchers as it is located in close proximity to a large pond. The trail section on the north/west side of the pond lies in a low area between two rising slopes. If the trail sees more use I recommend that the trail be moved uphill on the west slope for better drainage.

<b>Trail 12</b>												
FID	SurfaceMaterial	Vegetation	TreadWidth	TrailGrade	CrossSlope	SideSlope	TreadTask1	TreadTask2	ClearingHeight	ClearingWidth	ClearingTask	Length
0	Grass	Grass	80+	5-10	0	5-10	RoutineMaintenance	None	Open	80+	RoutineMaintenance	48
1	Grass	Grass	80+	11-15	>5	5-10	Repair	FullBenchConstruction	Open	80+	RoutineMaintenance	40
2	Grass	Grass	80+	11-15	<5	5-10	RoutineMaintenance	None	Open	80+	RoutineMaintenance	207
3	Grass	Grass	80+	>20	>10	>20	Relocate	None	Open	80+	RoutineMaintenance	116
4	Grass	Grass	80+	5-10	>5	16-20	Repair	FullBenchConstruction	Open	80+	RoutineMaintenance	145
5	Grass	Grass	80+	11-15	<5	16-20	Repair	FullBenchConstruction	Open	80+	RoutineMaintenance	124
											<b>Total (ft)</b>	<b>680</b>

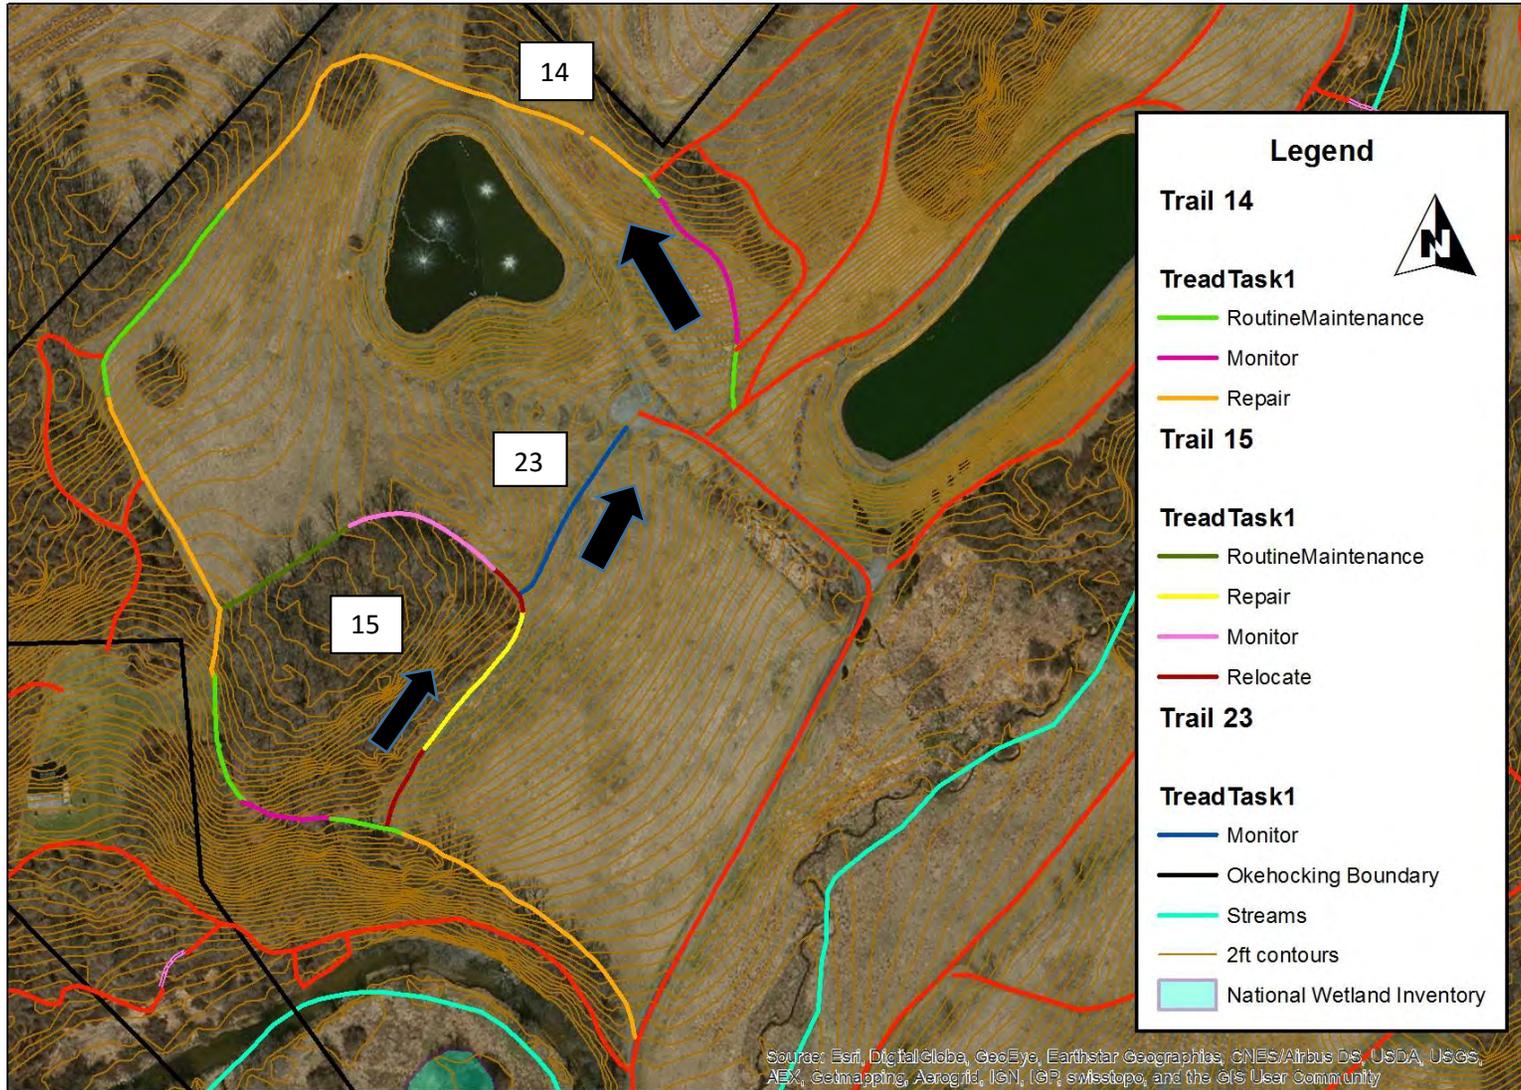
### Trails 14, 15 & 23 Tread Task 1

Trail 14 is a section of a larger loop advertised in the Okehocking Preserve brochure. This trail offers stunning views of the whole Preserve and one of the ponds. Trail 14 is highly used and could benefit from more amenities (benches) for its users. Sections that exceed 11-15 % grade show signs of erosion, cupping and displacement. I recommend crowing and compacting the tread due to the slope constraints of the area.

Trail 14												
FID	SurfaceMaterial	Vegetation	TreadWidth	TrailGrade	CrossSlope	SideSlope	TreadTask1	TreadTask2	ClearingHeight	ClearingWidth	ClearingTask	Length
0	Grass	Grass	80+	11-15	<5	11-15	RoutineMaintenance	None	Open	80+	RoutineMaintenance	83
1	Grass	Grass	80+	>20	<5	16-20	Monitor	None	Open	80+	RoutineMaintenance	63
2	Grass	Grass	80+	>30	<5	>30	Monitor	None	Open	80+	RoutineMaintenance	170
3	Grass	Grass	80+	11-15	<5	16-20	RoutineMaintenance	None	Open	80+	RoutineMaintenance	34
4	Dirt	Grass	13-25	<5	>1	5-10	Repair	OutslopeTread	Open	80+	RoutineMaintenance	83
5	Dirt	Grass	41-60	16-20	>1	16-20	Repair	CrownAndCompact	Open	80+	RoutineMaintenance	132
6	Grass	Grass	25-40	5-10	>1	5-10	Repair	CrownAndCompact	Open	80+	RoutineMaintenance	126
7	Grass	Grass	41-60	16-20	<5	16-20	Repair	CrownAndCompact	Open	80+	RoutineMaintenance	126
8	Grass	Grass	13-25	11-15	0	16-20	Repair	CrownAndCompact	Open	80+	RoutineMaintenance	61

9	Grass	Grass	13-25	16-20	0	16-20	Repair	CrownAndCompact	Open	80+	RoutineMaintenance	147
10	Grass	Grass	13-25	<5	<5	5-10	RoutineMaintenance	None	Open	80+	RoutineMaintenance	301
11	Grass	Grass	25-40	16-20	0	16-20	Repair	CrownAndCompact	Open	80+	RoutineMaintenance	117
12	Grass	Grass	13-25	5-10	0	5-10	Repair	CrownAndCompact	Open	80+	RoutineMaintenance	297
13	Grass	Grass	13-25	<5	<5	11-15	RoutineMaintenance	None	Open	80+	RoutineMaintenance	90
14	Grass	MatureForest	80+	5-10	<5	16-20	RoutineMaintenance	None	97-144	80+	RoutineMaintenance	85
15	Grass	MatureForest	80+	11-15	<5	16-20	Monitor	None	97-144	80+	RoutineMaintenance	128
16	Grass	Grass	13-25	5-10	<5	16-20	RoutineMaintenance	None	97-144	80+	RoutineMaintenance	96
17	Grass	Grass	25-40	11-15	0	11-15	Repair	CrownAndCompact	97-144	80+	RoutineMaintenance	427
											Total (ft)	2566

Trail 15 is a short loop that starts and ends on Trail 14. It is tree lined on one side and meadow on the other. The trail exceeds grades over 15% but does not show much erosion. I recommend routine maintenance until erosion becomes more prevalent.

Trail 15												
FID	SurfaceMaterial	Vegetation	TreadWidth	TrailGrade	CrossSlope	SideSlope	TreadTask1	TreadTask2	ClearingHeight	ClearingWidth	ClearingTask	Length
0	Grass	Grass	<12	16-20	>5	16-20	Relocate	None	Open	80+	RoutineMaintenance	114
1	Grass	Grass	<12	5-10	>5	11-15	Repair	FullBenchConstruct	Open	80+	RoutineMaintenance	51
2	Grass	Grass	<12	<5	>5	11-15	Repair	FullBenchConstruct	Open	80+	RoutineMaintenance	167
3	Grass	Grass	<12	16-20	<5	16-20	Relocate	None	Open	80+	RoutineMaintenance	69
4	Grass	Grass	<12	5-10	<5	5-10	Monitor	None	Open	80+	RoutineMaintenance	217
5	Grass	Grass	<12	<5	0	<5	RoutineMaintenance	None	Open	80+	RoutineMaintenance	198
											Total (ft)	816

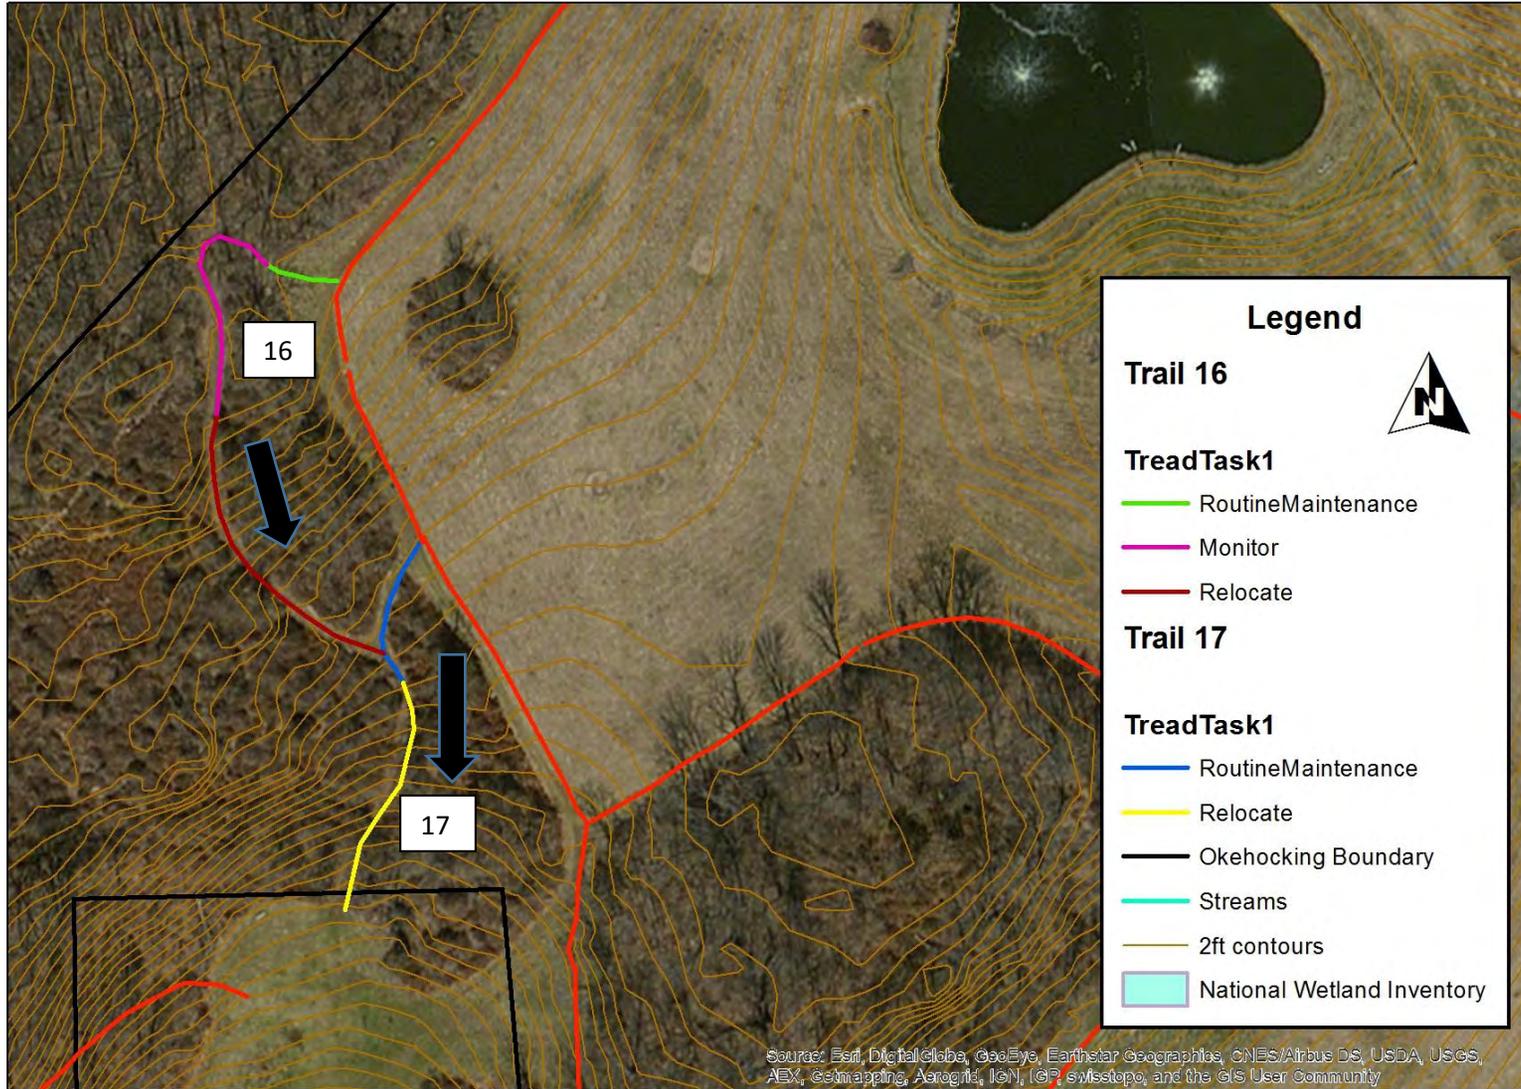
### Trails 16 & 17 Tread Task 1

<b>Trail 16</b>												
FID	SurfaceMaterial	Vegetation	TreadWidth	TrailGrade	CrossSlope	SideSlope	TreadTask1	TreadTask2	ClearingHeight	ClearingWidth	ClearingTask	Length
0	Grass	Grass	<12	5-10	0	5-10	RoutineMaintenance	None	Open	80+	RoutineMaintenance	47
1	Grass	MatureForest	13-25	5-10	>-1	5-10	Monitor	None	<60	61-80	Repair/Vertical Clearance	57
2	Grass	MatureForest	13-25	<5	0	<5	Monitor	None	97-144	80+	RoutineMaintenance	74
3	Grass	MatureForest	13-25	16-20	0	16-20	Relocate	None	97-144	80+	RoutineMaintenance	189
											<b>Total (ft)</b>	<b>367</b>

Trail 17												
FID	SurfaceMaterial	Vegetation	TreadWidth	TrailGrade	CrossSlope	SideSlope	TreadTask1	TreadTask2	ClearingHeight	ClearingWidth	ClearingTask	Length
0	Grass	YoungForest	13-25	<5	<5	5-10	RoutineMaintenance	None	97-144	80+	RoutineMaintenance	94
1	Grass	MatureForest	25-40	>20	0	>20	Relocate	None	73-96	41-60	Repair	152
											Total (ft)	246

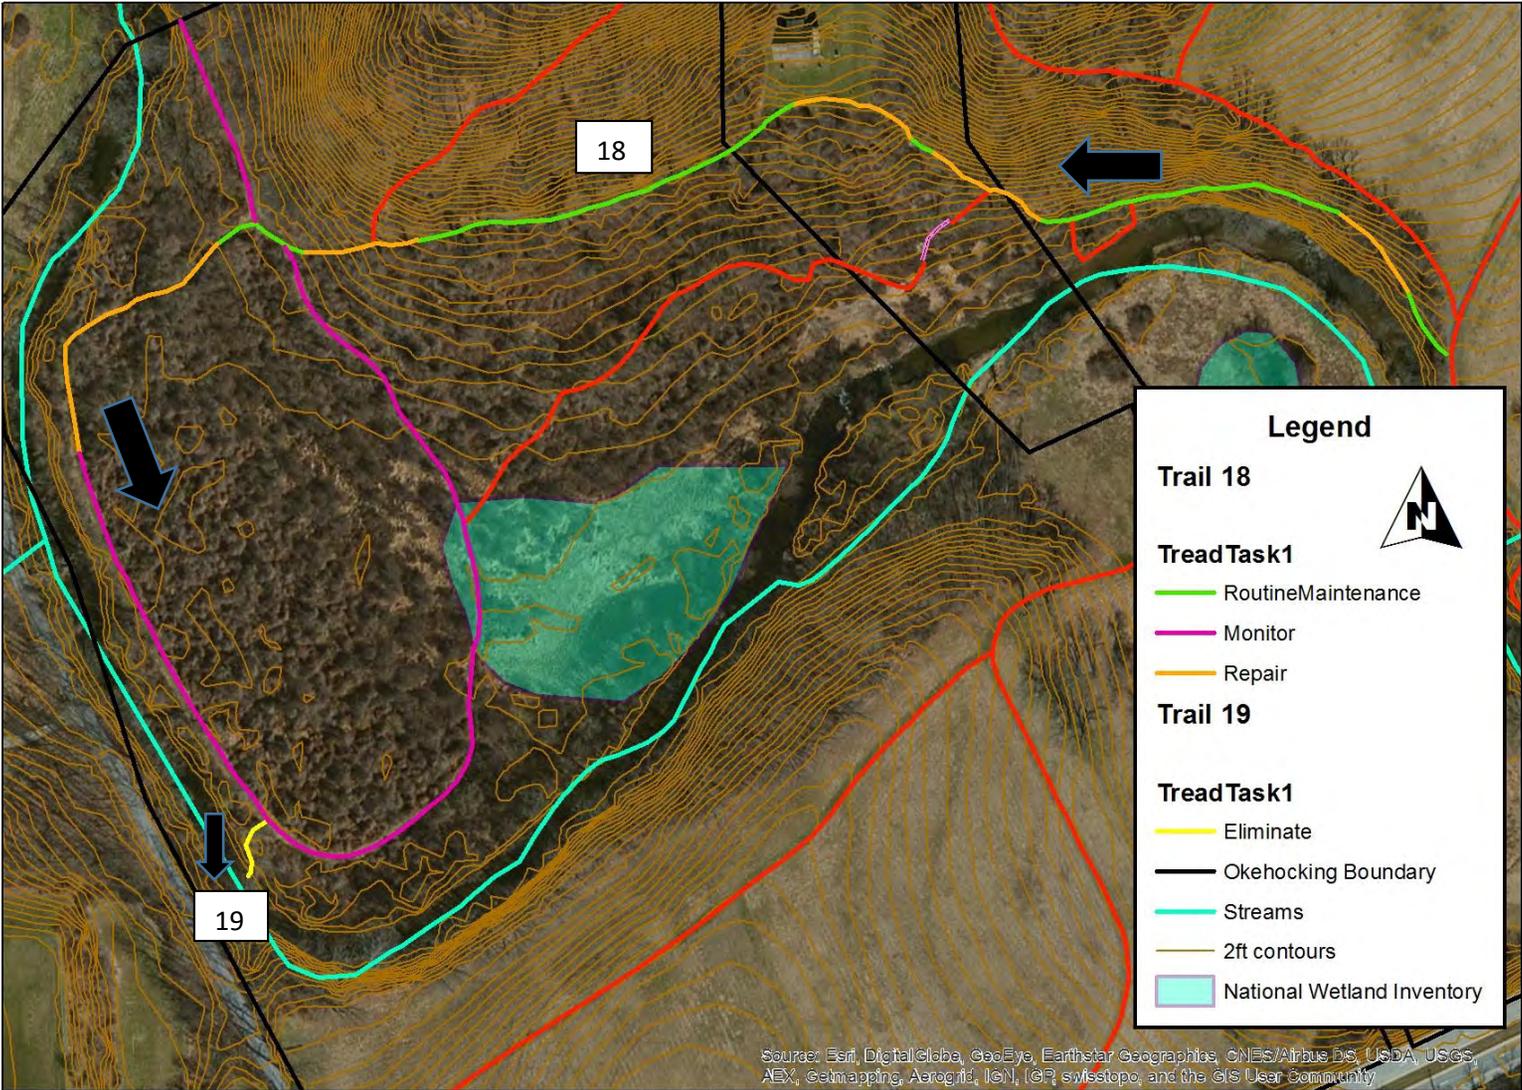
### Trails 18 & 19 Tread Task 1

Trail 18												
FID	SurfaceMaterial	Vegetation	TreadWidt	TrailGrade	CrossSlope	SideSlope	TreadTask1	TreadTask2	ClearingHeight	ClearingWid th	ClearingTask	Length
0	Dirt	MatureForest	13-25	<5	0	5-10	RoutineMaintenance	None	73-96	61-80	RoutineMaintenance	90
1	Dirt	MatureForest	41-60	11-15	>1	>20	Repair	OutslopeTread/add dips	73-96	61-80	RoutineMaintenance	125
2	Dirt	MatureForest	25-40	5-10	<5	16-20	RoutineMaintenance	None	73-96	61-80	RoutineMaintenance	101
3	Dirt	MatureForest	41-60	5-10	<5	16-20	RoutineMaintenance	None	73-96	61-80	RoutineMaintenance	66
4	Dirt	MatureForest	13-25	<5	0	11-15	RoutineMaintenance	None	73-96	61-80	RoutineMaintenance	204
5	Dirt	MatureForest	13-25	16-20	>1	16-20	Repair	FullBenchConstruct	73-96	61-80	RoutineMaintenance	150
6	Dirt	MatureForest	13-25	<5	0	5-10	RoutineMaintenance	None	61-72	25-40	RoutineMaintenance	31
7	Dirt	Shrub/Sapling	13-25	16-20	>1	16-20	Repair	AddRetainers/Steps	97-144	61-80	RoutineMaintenance	34

8	Dirt	Shrub/Sapling	13-25	5-10	>1	11-15	Repair	CrownAndCompact	97-144	61-80	RoutineMaintenance	43
9	Dirt	Grass	80+	<5	>5	5-10	Repair	FullBenchConstruct	Open	80+	RoutineMaintenance	84
10	Dirt	Grass	80+	5-10	<5	5-10	RoutineMaintenance	None	Open	80+	RoutineMaintenance	42
11	Dirt	Grass	13-25	<5	0	5-10	RoutineMaintenance	None	Open	80+	RoutineMaintenance	442
12	Dirt	Grass	25-40	11-15	>1	11-15	Repair	CrownAndCompact	Open	80+	RoutineMaintenance	131
13	Dirt	Grass	25-40	<5	0	5-10	RoutineMaintenance	None	Open	80+	RoutineMaintenance	108
14	Dirt	MatureForest	80+	<5	>1	<5	Repair	Add Turnpike	97-144	80+	RoutineMaintenance	120
15	Grass	Shrub/Sapling	41-60	<5	>1	<5	Repair	CrownAndCompact or Turnpike	97-144	80+	RoutineMaintenance	217
16	Grass	Shrub/Sapling	41-60	5-10	0	5-10	Monitor	None	97-144	80+	RoutineMaintenance	1485
17	Grass	Shrub/Sapling	25-40	5-10	0	5-10	Monitor	None	97-144	80+	RoutineMaintenance	100
											Total (ft)	3573

Trail 19												
FID	SurfaceMaterial	Vegetation	TreadWidth	TrailGrade	CrossSlope	SideSlope	TreadTask1	TreadTask2	ClearingHeight	ClearingWidth	ClearingTask	Length
0	Dirt	MatureForest	<12	<5	0	<5	Eliminate	None	<60	41-60	RoutineMaintenance	68
