# **OKEHOCKING PRESERVE TRAIL SYSTEM**

## **TRAIL ASSESSMENT AND PRESCRIPTIONS REPORT**

**JUNE 2, 2016**

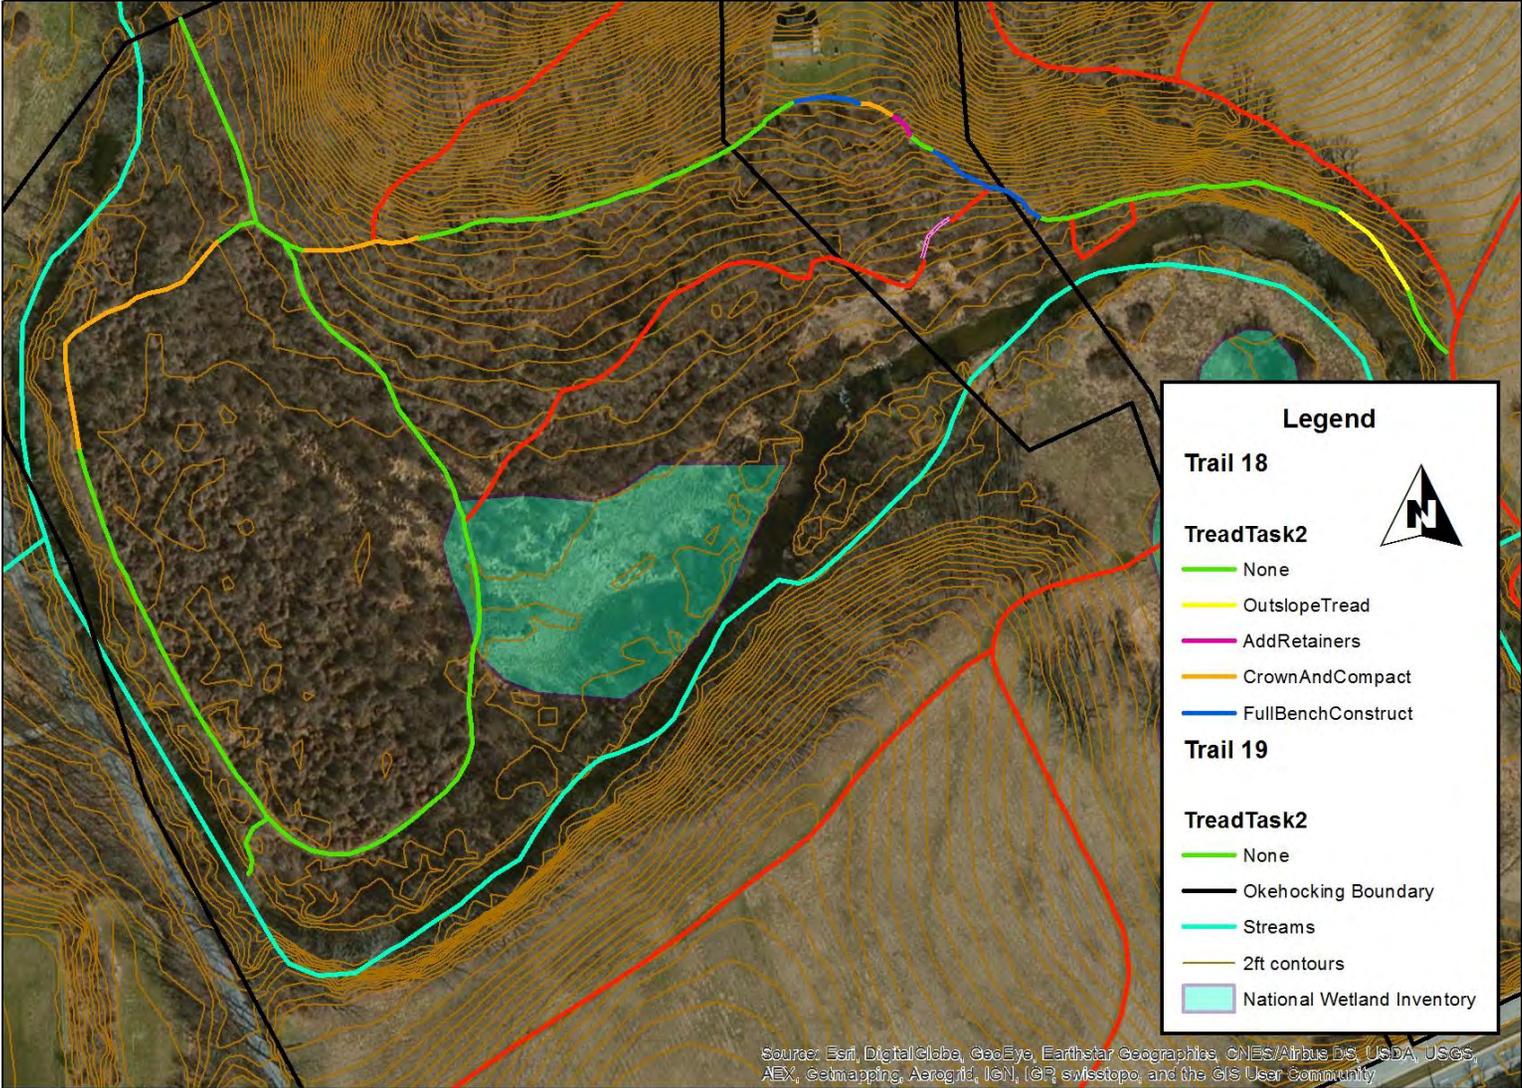
Trails 18 & 19 Tread Task 2

Trail 18												
FID	SurfaceMaterial	Vegetation	TreadWidt	TrailGrade	CrossSlope	SideSlope	TreadTask1	TreadTask2	ClearingHeight	ClearingWid th	ClearingTask	Length
0	Dirt	MatureForest	13-25	<5	0	5-10	RoutineMaintenance	None	73-96	61-80	RoutineMaintenance	90
1	Dirt	MatureForest	41-60	11-15	>1	>20	Repair	OutslopeTread/add dips	73-96	61-80	RoutineMaintenance	125
2	Dirt	MatureForest	25-40	5-10	<5	16-20	RoutineMaintenance	None	73-96	61-80	RoutineMaintenance	101
3	Dirt	MatureForest	41-60	5-10	<5	16-20	RoutineMaintenance	None	73-96	61-80	RoutineMaintenance	66
4	Dirt	MatureForest	13-25	<5	0	11-15	RoutineMaintenance	None	73-96	61-80	RoutineMaintenance	204
5	Dirt	MatureForest	13-25	16-20	>1	16-20	Repair	FullBenchConstruct	73-96	61-80	RoutineMaintenance	150
6	Dirt	MatureForest	13-25	<5	0	5-10	RoutineMaintenance	None	61-72	25-40	RoutineMaintenance	31
7	Dirt	Shrub/Sapling	13-25	16-20	>1	16-20	Repair	AddRetainers/Steps	97-144	61-80	RoutineMaintenance	34

8	Dirt	Shrub/Sapling	13-25	5-10	>1	11-15	Repair	CrownAndCompact	97-144	61-80	RoutineMaintenance	43
9	Dirt	Grass	80+	<5	>5	5-10	Repair	FullBenchConstruct	Open	80+	RoutineMaintenance	84
10	Dirt	Grass	80+	5-10	<5	5-10	RoutineMaintenance	None	Open	80+	RoutineMaintenance	42
11	Dirt	Grass	13-25	<5	0	5-10	RoutineMaintenance	None	Open	80+	RoutineMaintenance	442
12	Dirt	Grass	25-40	11-15	>1	11-15	Repair	CrownAndCompact	Open	80+	RoutineMaintenance	131
13	Dirt	Grass	25-40	<5	0	5-10	RoutineMaintenance	None	Open	80+	RoutineMaintenance	108
14	Dirt	MatureForest	80+	<5	>1	<5	Repair	Add Turnpike	97-144	80+	RoutineMaintenance	120
15	Grass	Shrub/Sapling	41-60	<5	>1	<5	Repair	CrownAndCompact or Turnpike	97-144	80+	RoutineMaintenance	217
16	Grass	Shrub/Sapling	41-60	5-10	0	5-10	Monitor	None	97-144	80+	RoutineMaintenance	1485
17	Grass	Shrub/Sapling	25-40	5-10	0	5-10	Monitor	None	97-144	80+	RoutineMaintenance	100
											Total (ft)	3573

Trail 19												
FID	SurfaceMaterial	Vegetation	TreadWidth	TrailGrade	CrossSlope	SideSlope	TreadTask1	TreadTask2	ClearingHeight	ClearingWidth	ClearingTask	Length
0	Dirt	MatureForest	<12	<5	0	<5	Eliminate	None	<60	41-60	RoutineMaintenance	68

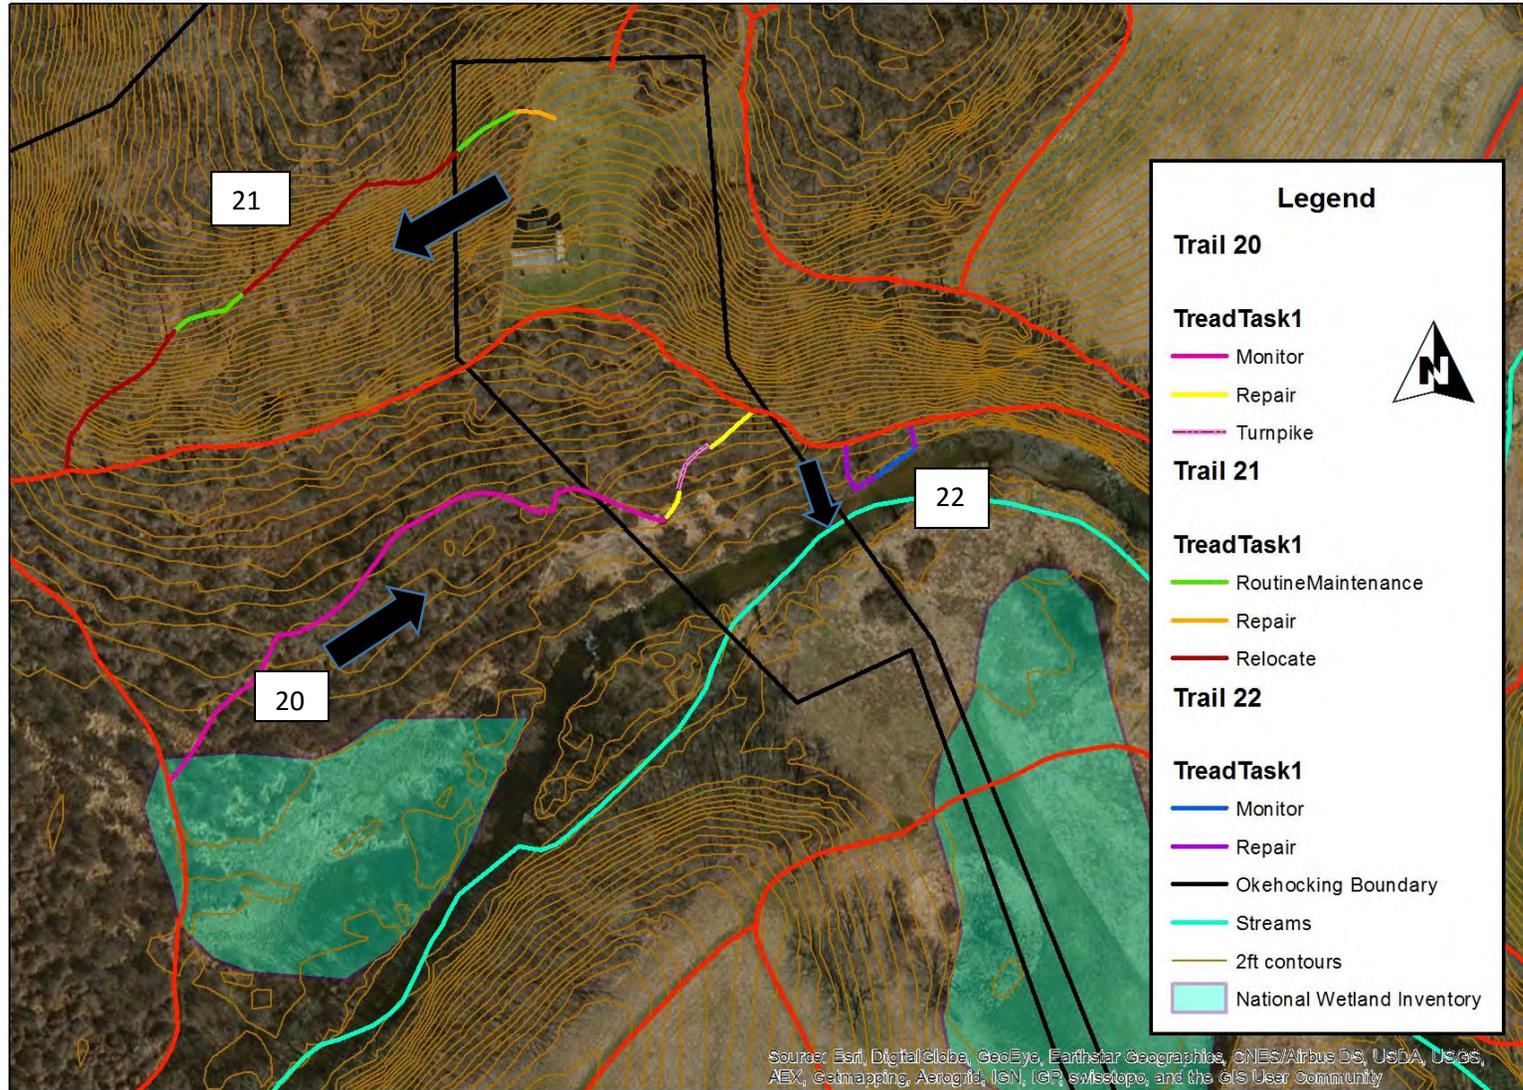
### Trails 20 - 22 Tread Task 1

Trail 20												
FID	SurfaceMaterial	Vegetation	TreadWidth	TrailGrade	CrossSlope	SideSlope	TreadTask1	TreadTask2	ClearingHeight	ClearingWidth	ClearingTask	Length
0	Grass	YoungForest	13-25	<5	>1	<5	Monitor	None	73-96	80+	RoutineMaintenance	606
1	Grass	Shrub/Sapling	13-25	<5	>1	<5	Monitor	None	Open	80+	RoutineMaintenance	91
2	Grass	Shrub/Sapling	41-60	5-10	>.5	5-10	Repair	Turnpike	Open	80+	RoutineMaintenance	29
3	Grass	MatureForest	13-25	5-10	>1	5-10	Repair	CrownAndCompact	73-96	61-80	RoutineMaintenance	58
											Total (ft)	784

Trail 21 connect the historic Goulders Barn and Trail 18. It offers and intimate experience with mature forest. The trail is mostly fall line and exceed 20% grade. I recommend relocation for an overall better experience.

<b>Trail 21</b>												
FID	SurfaceMaterial	Vegetation	TreadWidth	TrailGrade	CrossSlope	SideSlope	TreadTask1	TreadTask2	ClearingHeight	ClearingWidth	ClearingTask	Length
0	Dirt	MatureForest	13-25	11-15	0	11-15	Repair	CrownAndCompact	61-72	41-60	RoutineMaintenance	45
1	Dirt	MatureForest	13-25	5-10	<5	16-20	RoutineMaintenance	None	61-72	41-60	RoutineMaintenance	76
2	Dirt	MatureForest	13-25	>20	>5	>20	Relocate	None	61-72	41-60	RoutineMaintenance	286
3	Dirt	MatureForest	13-25	5-10	0	11-15	RoutineMaintenance	None	61-72	41-60	RoutineMaintenance	83
4	Dirt	MatureForest	13-25	>20	>1	>20	Relocate	None	61-72	41-60	RoutineMaintenance	57
5	Dirt	MatureForest	13-25	11-15	>1	16-20	Relocate	None	61-72	41-60	RoutineMaintenance	50
6	Dirt	MatureForest	13-25	>20	>1	>20	Relocate	None	<60	41-60	Repair	81
											Total (ft)	678

<b>Trail 22</b>												
FID	SurfaceMaterial	Vegetation	TreadWidt	TrailGrade	CrossSlope	SideSlope	TreadTask1	TreadTask2	ClearingHeight	ClearingWidth	ClearingTask	Length
0	Dirt	MatureForest	25-40	5-10	0	5-10	Repair	Add steps or eliminate	97-144	61-80	RoutineMaintenance	73
1	Dirt	MatureForest	<12	<5	0	5-10	Monitor	None	97-144	61-80	RoutineMaintenance	51
2	Dirt	MatureForest	13-25	11-15	0	11-15	Repair	Add steps	97-144	61-80	RoutineMaintenance	29
											Total (ft)	153

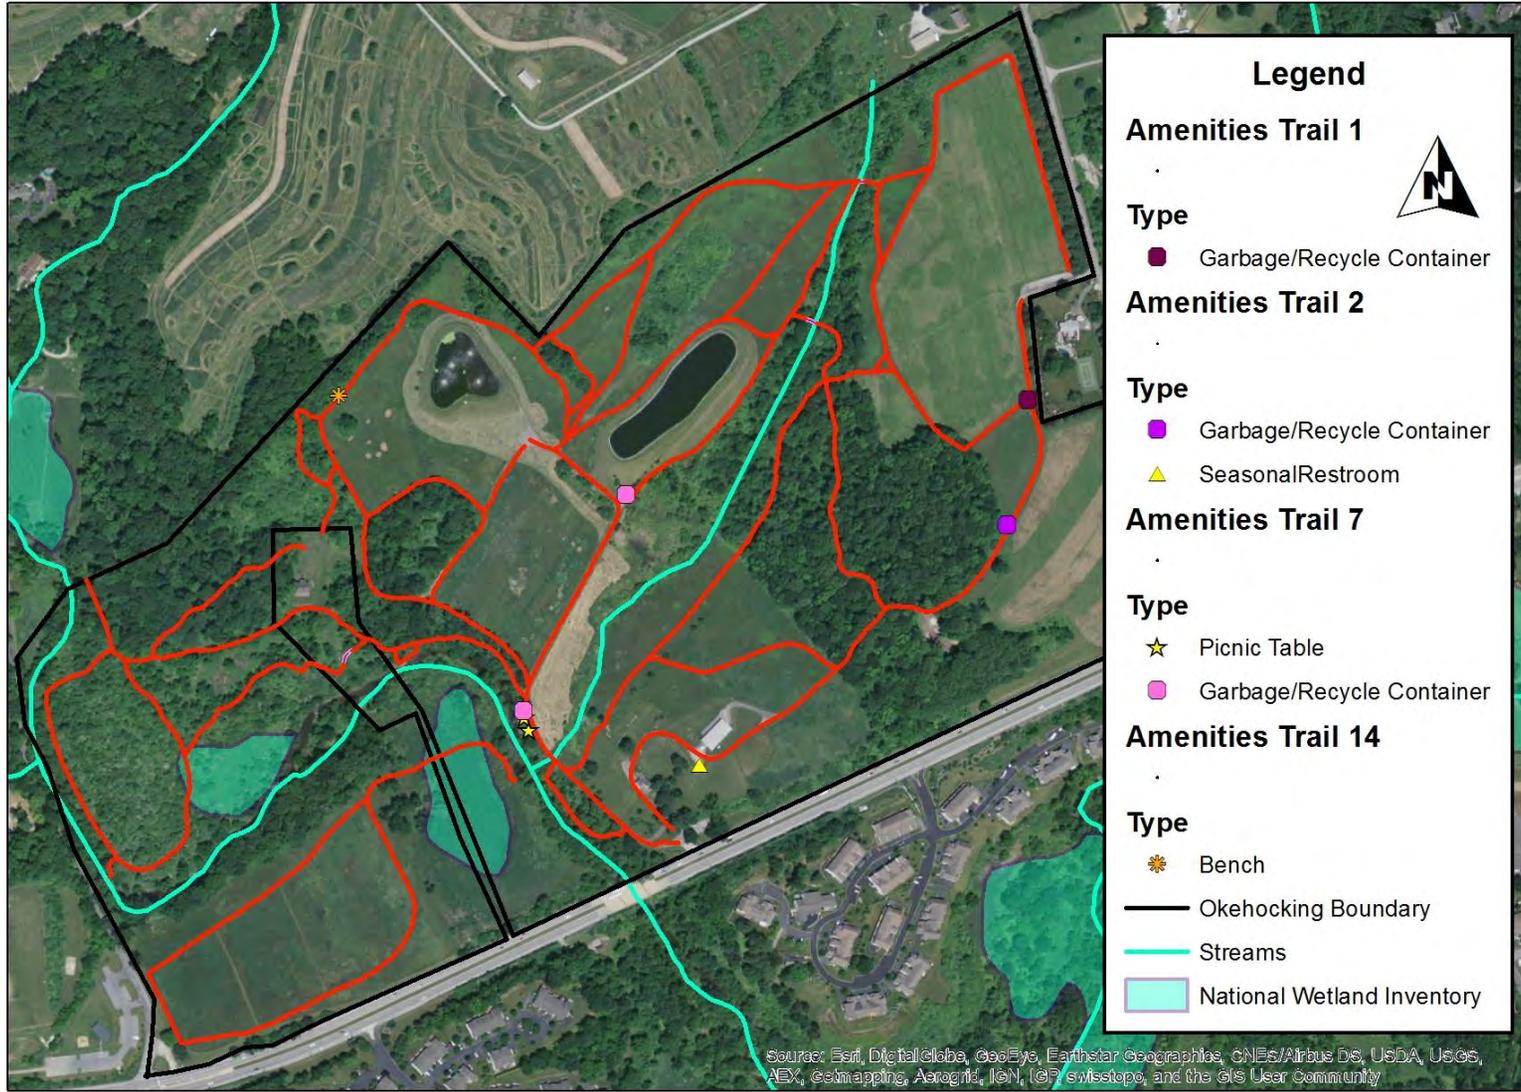
### Amenities

Amenities													
	FID	Type	ADAAccessible	Removable	Vandalism	Length(ft)	Width(in)	Height(in)	Diameter(in)	MaterialType	FeatureTask	X	Y
<b>Trail 1</b>	0	Garbage/Recycle Container	Unspecified	Yes	No	0	21	24	0	Metal	RoutineMaintenance	-75.477694	39.971299
<b>Trail 2</b>	0	Garbage/Recycle Container	Unspecified	Yes	No	0	0	25	21	Metal	RoutineMaintenance	-75.477986	39.970128
	1	SeasonalRestroom	Yes	Yes	No	5	60	72	0	Composite	RoutineMaintenance	-75.481822	39.967952
<b>Trail 7</b>	0	Picnic Table	No	Yes	No	8	42	31	0	Treated Lumber	RoutineMain	-75.483891	39.968321
	1	Picnic Table	No	Yes	Yes	8	42	31	0	Treated Lumber	Repair/sand off graffiti	-75.483942	39.968441
	2	Garbage/Recycle Container	No	Yes	No	0	0	25	21	Metal	RoutineMaintenance	-75.483949	39.968489
	3	Garbage/Recycle Container	No	Yes	No	0	0	25	21	Metal	RoutineMaintenance	-75.482632	39.970498
	0	Bench	No	Yes	No	5	18	21	0	Treated Lumber	Replace seating boards	-75.48611	39.971506

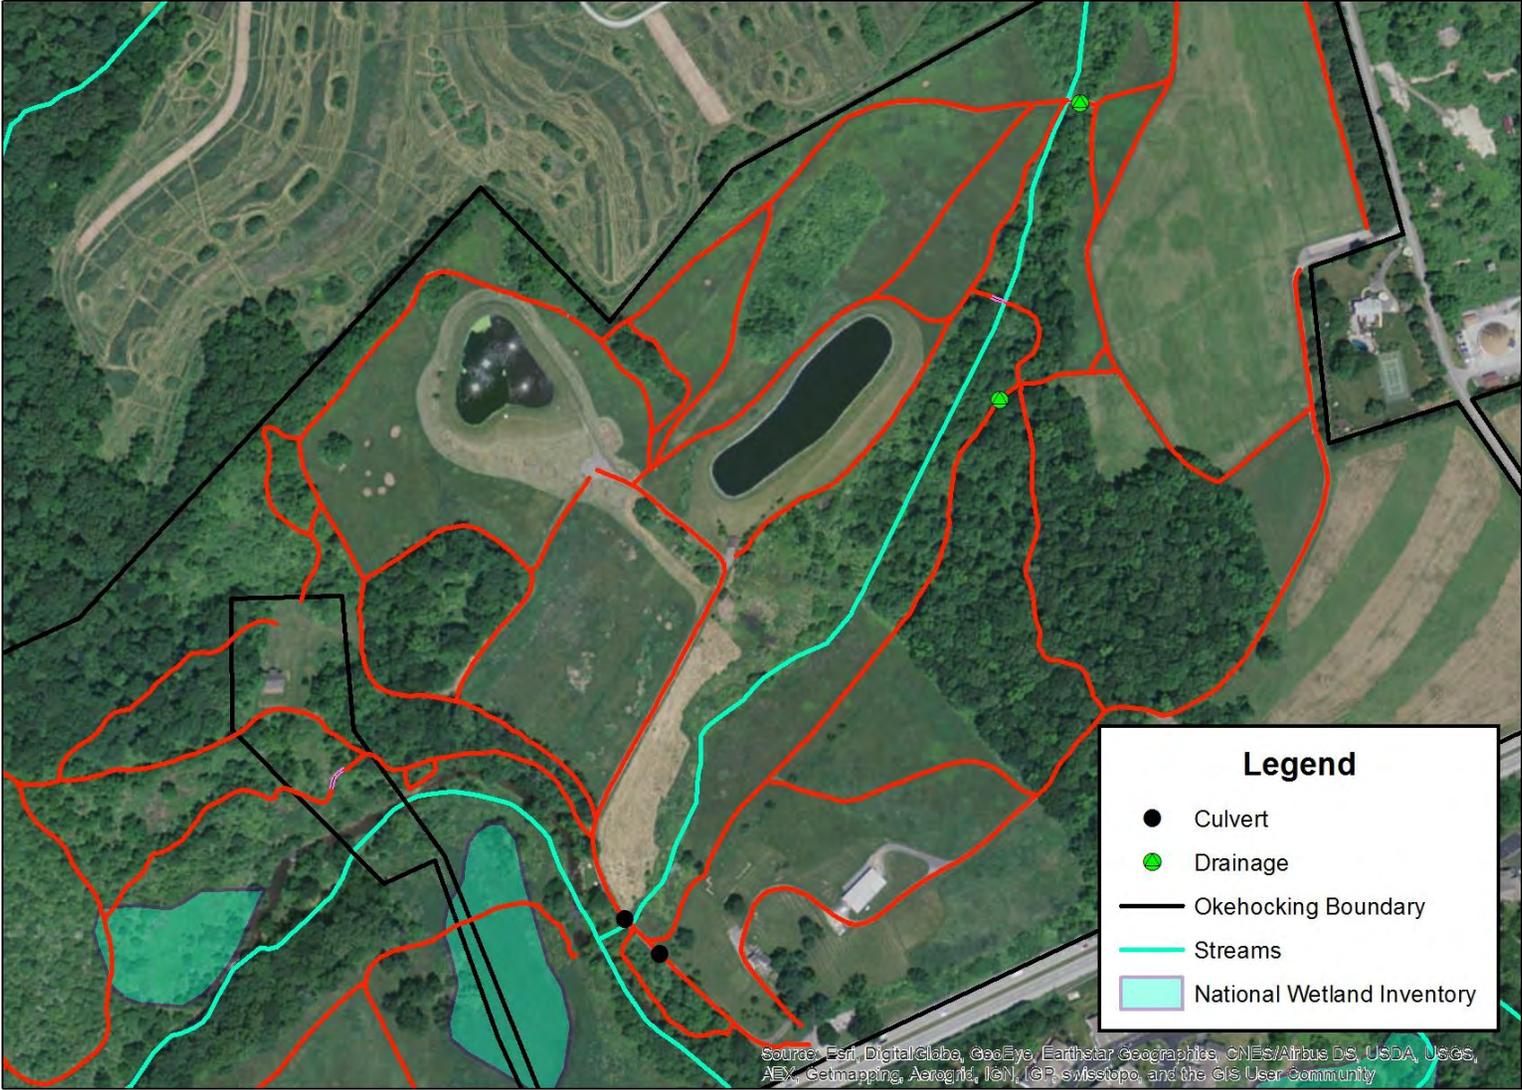
### Culverts and Drainage

<b>Culvert Trail 7</b>										
FID	Type	Quantity	Length(ft)	Diameter(in)	MaterialType	FeatureTask	TaskComments	X	Y	
0	Standard	1	18	18	Metal	Repair	remove rocks from uphill entrance	-75.48337	39.967849	
1	Unspecified	1	10	32	Concrete	Unspecified	need guard rails	-75.483657	39.968081

<b>Drainage</b>												
FID	Type	Length_f	Width_i	Depth_i	Height_i	TrailwayMaterial	OutletMaterial	FeatureTask	TaskComments	X	Y	
<b>Trail 4</b>	0	Drainage Dip	4	12	6	0	Native Soil	Native Soil	Repair	widen drain on downhill side	-75.480336	39.971434
<b>Trail 9</b>	0	Drainage Dip	9	18	8	0	Native Soil	Native Soil	Repair	undercutting abutment	-75.47958	39.973373

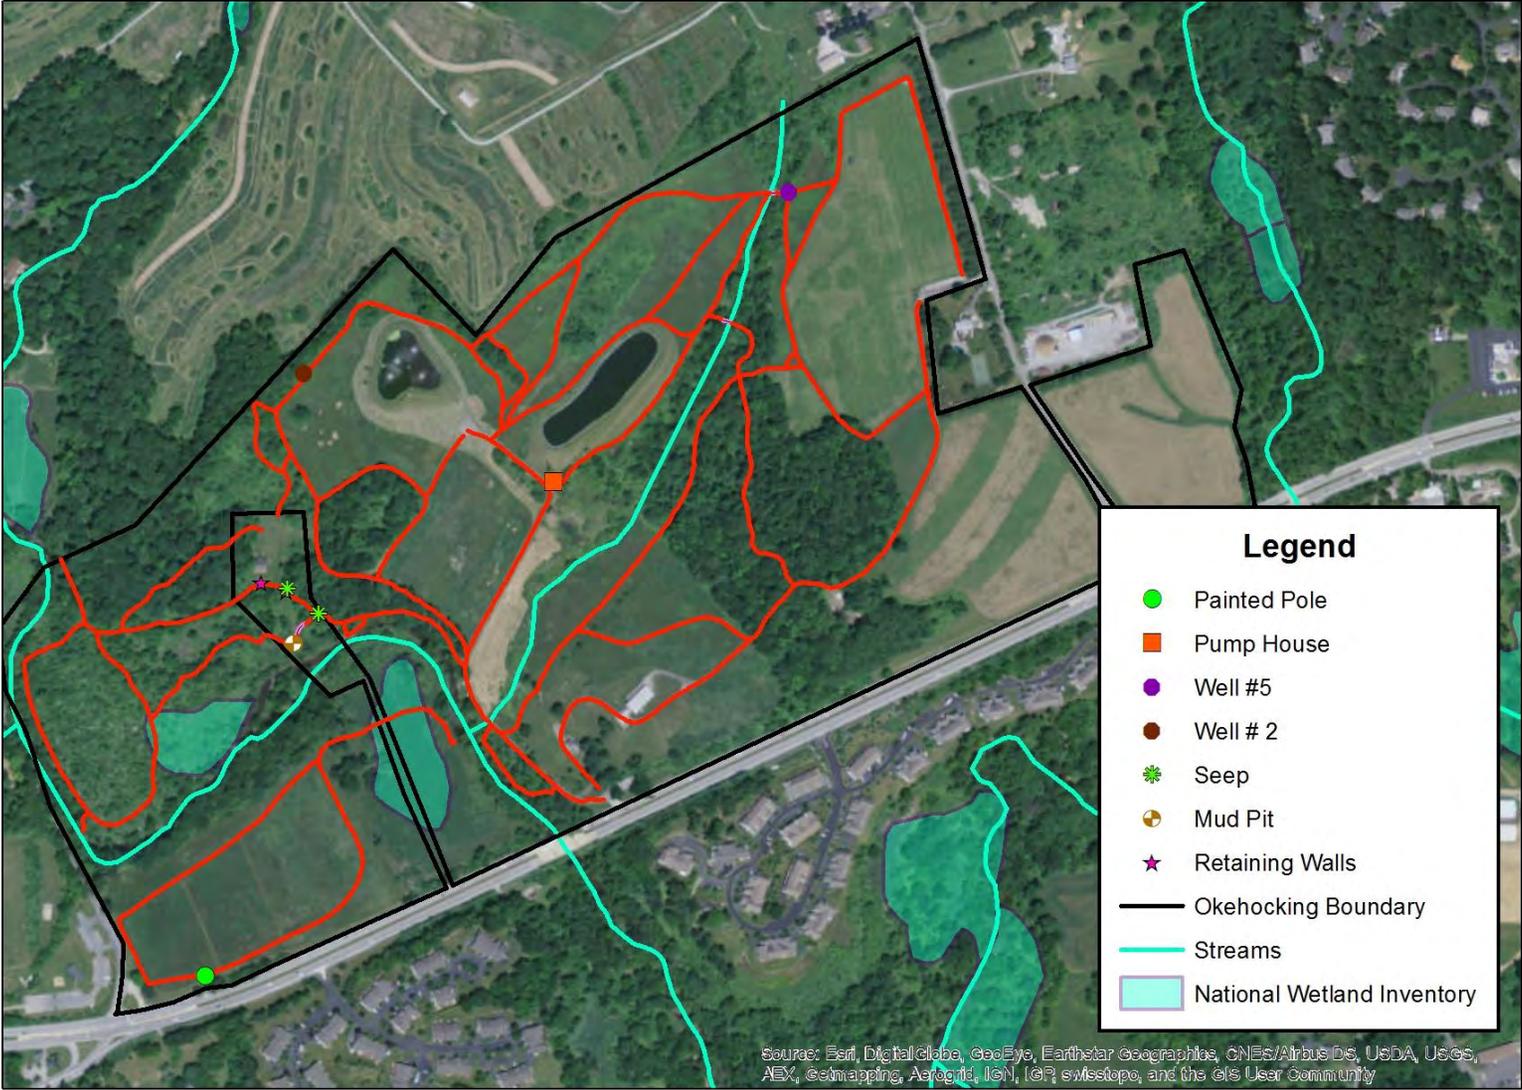
Points of Interest

<b>Point Of Interest</b>							
	<b>FID</b>	<b>Type</b>	<b>TypeComments</b>	<b>MaterialType</b>	<b>GeneralComments</b>	<b>X</b>	<b>Y</b>
<b>Trail 6</b>	0	Other	post	Treated Log	art	-75.487481	39.965519
<b>Trail 7</b>	0	Building	Pump House	Rock	combo lock on door	-75.48267	39.970489
<b>Trail 9</b>	0	Other	well 5	Metal	N/A	-75.479437	39.973399
<b>Trail 14</b>	0	Other	well 2	Metal	N/A	-75.485958	39.971669
<b>Trail 18</b>	0	Other	hole in tread	Native Soil	N/A	-75.48584	39.96921
	1	Other	seep	Native Soil	N/A	-75.486254	39.96947
<b>Trail 20</b>	0	Other	mudpitt	Native Soil	N/A	-75.48619	39.968907

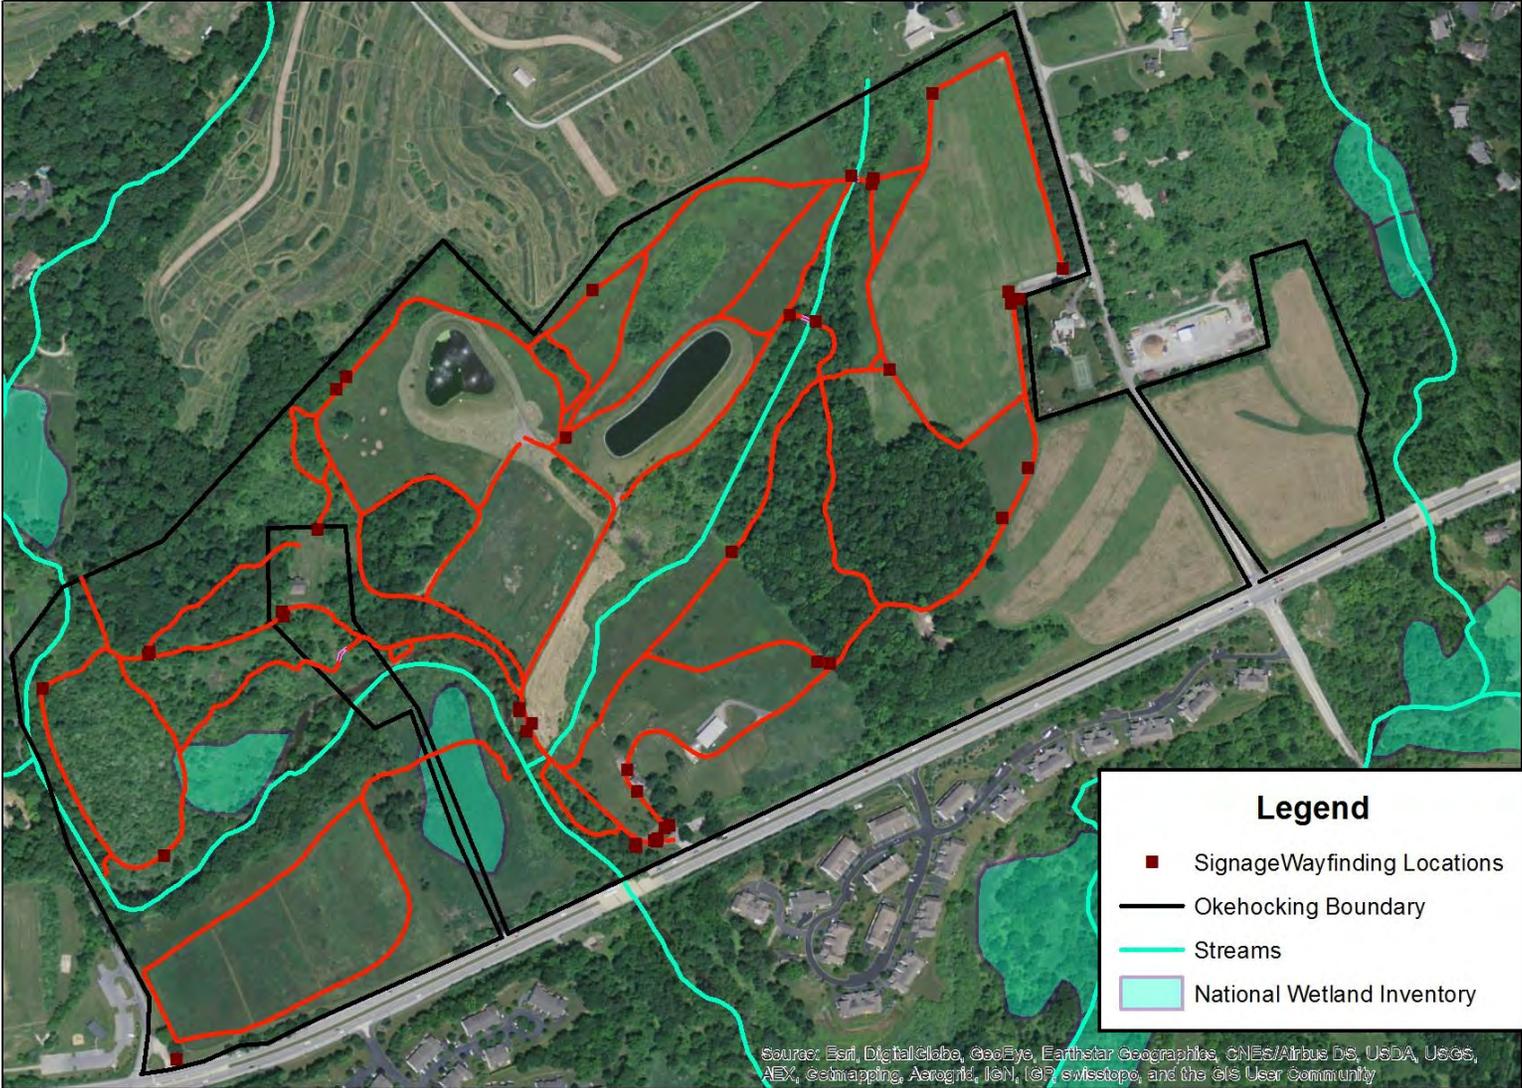
### Signage and Wayfinding

SignageWayfinding												
	FID	Type	Mounting	SignType	Vandalism	Length(in)	Width(in)	MountingHeight(in)	SignMaterial	FeatureTask	X	Y
<b>Trail 1</b>	0	Sign	MetalPost	Regulatory	No	24	12	60	Metal	RoutineMaintenance	-75.477161	39.972504
	1	Sign	MetalPost	Regulatory	No	24	12	60	Metal	RoutineMaintenance	-75.475704	39.974177
	2	Other	WoodPost	Wayfinding	No	4	4	60	Composite	Repair/Staighthen	-75.479311	39.971597
<b>Trail 2</b>	0	Sign	MetalPost	Regulatory	No	12	10	48	Metal	RoutineMaintenance	-75.477648	39.970636
	1	Sign	MetalPost	Regulatory	No	24	18	96	Metal	RoutineMaintenance	-75.477987	39.970173
	2	Sign	MetalPost	Regulatory	No	24	18	96	Metal	RoutineMaintenance	-75.48013	39.968847
	3	Sign	WoodPost	Informational	No	24	18	62	Metal	RoutineMaintenance	-75.482527	39.967695
	4	Sign	WoodPost	Informational	No	12	6	62	Composite	RoutineMaintenance	-75.482646	39.967895
<b>Trail 3</b>	0	Sign	MetalPost	Informational	No	36	24	60	Metal	RoutineMaintenance	-75.480286	39.968873

<b>Trail 4</b>	0	Sign	WoodPost	Informational	No	13	6	48	Composite	RoutineMaintenance	-75.481296	39.969923
<b>Trail 5</b>	0	Sign	WoodPost	Regulatory	No	24	18	42	Plastic/cardboard	RoutineMaintenance	-75.480517	39.972133
	1	Sign	WoodPost	Regulatory	No	24	18	42	Plastic/cardboard	Replace	-75.480201	39.972068
<b>Trail 7</b>	0	InformationKiosk	WoodPost	Informational	No	6	48	60	Paper	RoutineMaintenance	-75.482562	39.967174
	1	Sign	MetalPost	Regulatory	No	24	18	64	Plastic	Replace	-75.482573	39.9672
	2	Sign	MetalPost	Regulatory	No	24	12	40	Metal	RoutineMaintenance	-75483863	39.968285
	3	Sign	MetalPost	Regulatory	No	24	12	120	Metal	RoutineMaintenance	-75483796	39.968357
	4	Sign	WoodPost	Informational	No	4	4	60	Composite	RoutineMaintenance	-75483945	39.968482
	5	Sign	MetalPost	Regulatory	No	24	18	48	Metal	RoutineMaintenance	-75.483945	39.968506
<b>Trail 9</b>	0	Sign	WoodPost	Informational	No	4	4	60	Composite	Repair/Straighthen	-75.479722	39.973424

1	Sign	WoodPost	Regulatory	Yes	24	12	60	Metal	Replace	-75.479467	39.973343
	2	Sign	WoodPost	Informational	No	10	12	72	Metal	RoutineMaintenance	-75.479442	39.973399
	3	Sign	WoodPost	Interpretive	No	4	4	42	Composite	RoutineMaintenance	-75.482918	39.972416
<b>Trail 10</b>	0	Sign	MetalPost	Regulatory	No	18	12	125	Metal	Repair/Clean	-75.483294	39.97104

<b>Trail 17</b>	0	Sign	MetalPost	Wayfinding	No	8	6	48	Metal	Repair/redirect	-75.486355	39.970234
<b>Trail 18</b>	0	Sign	WoodPost	Informational	No	4	4	60	Composite	RoutineMaintenance	-75.486815	39.96947
	1	Sign	WoodPost	Wayfinding	No	6	18	48	Lumber	RoutineMaintenance	-75.486798	39.969428
	2	Sign	WoodPost	Wayfinding	No	6	18	48	Lumber	RoutineMaintenance	-75.488465	39.969101
	3	Sign	WoodPost	Informational	No	4	4	55	Composite	RoutineMaintenance	-75.489762	39.968802
	4	Sign	WoodPost	Interpretive	No	4	4	43	Composite	RoutineMaintenance	-75.488331	39.967207
<b>Trail 21</b>	0	Sign	WoodPost	Informational	No	4	4	62	Composite	RoutineMaintenance	-75.488442	39.969118
<b>Trailhead 1</b>	0	Sign	Other	Informational	No	12	18	42	Metal	RoutineMaintenance	-75.477835	39.9723
	1	Sign	Other	Informational	No	18	18	60	Metal	RoutineMaintenance	-75.47771	39.972228
	2	Sign	Other	Informational	Yes	24	24	36	Metal	Repair	-75.477711	39.972232

3	Sign	MetalPost	Regulatory	No	36	36	72	Metal	RoutineMaintenance	-75.477805	39.972186
	4	InformationKiosk	WoodPost	Informational	No	6	47	72	Unspecified	RoutineMaintenance	-75.477803	39.97221
	5	Sign	WoodPost	Identificationl	No	4	72	96	Unspecified	Repair/New Paint	-75.488345	39.96529
<b>Trailhead 2</b>	0	Sign	WoodPost	Regulatory	No	2	12	48	Metal	RoutineMaintenance	-75.482206	39.967346
	1	Sign	WoodPost	Informational	No	2	6	36	Lumber	RoutineMaintenance	-75.482148	39.967367
	2	Sign	WoodPost	Regulatory	No	2	12	42	Metal	RoutineMaintenance	-75.482305	39.967224
	3	Sign	WoodPost	Informational	No	2	6	48	Lumber	RoutineMaintenance	-75.482297	39.967246
	4	Sign	WoodPost	Regulatory	No	2	18	52	Metal	RoutineMaintenance	-75.48234	39.967233
